April 24, 2020

**2020 Annual Inspection of CCR Facilities
Bull Run Fossil (BRF) Plant
Clinton, Anderson County, Tennessee**

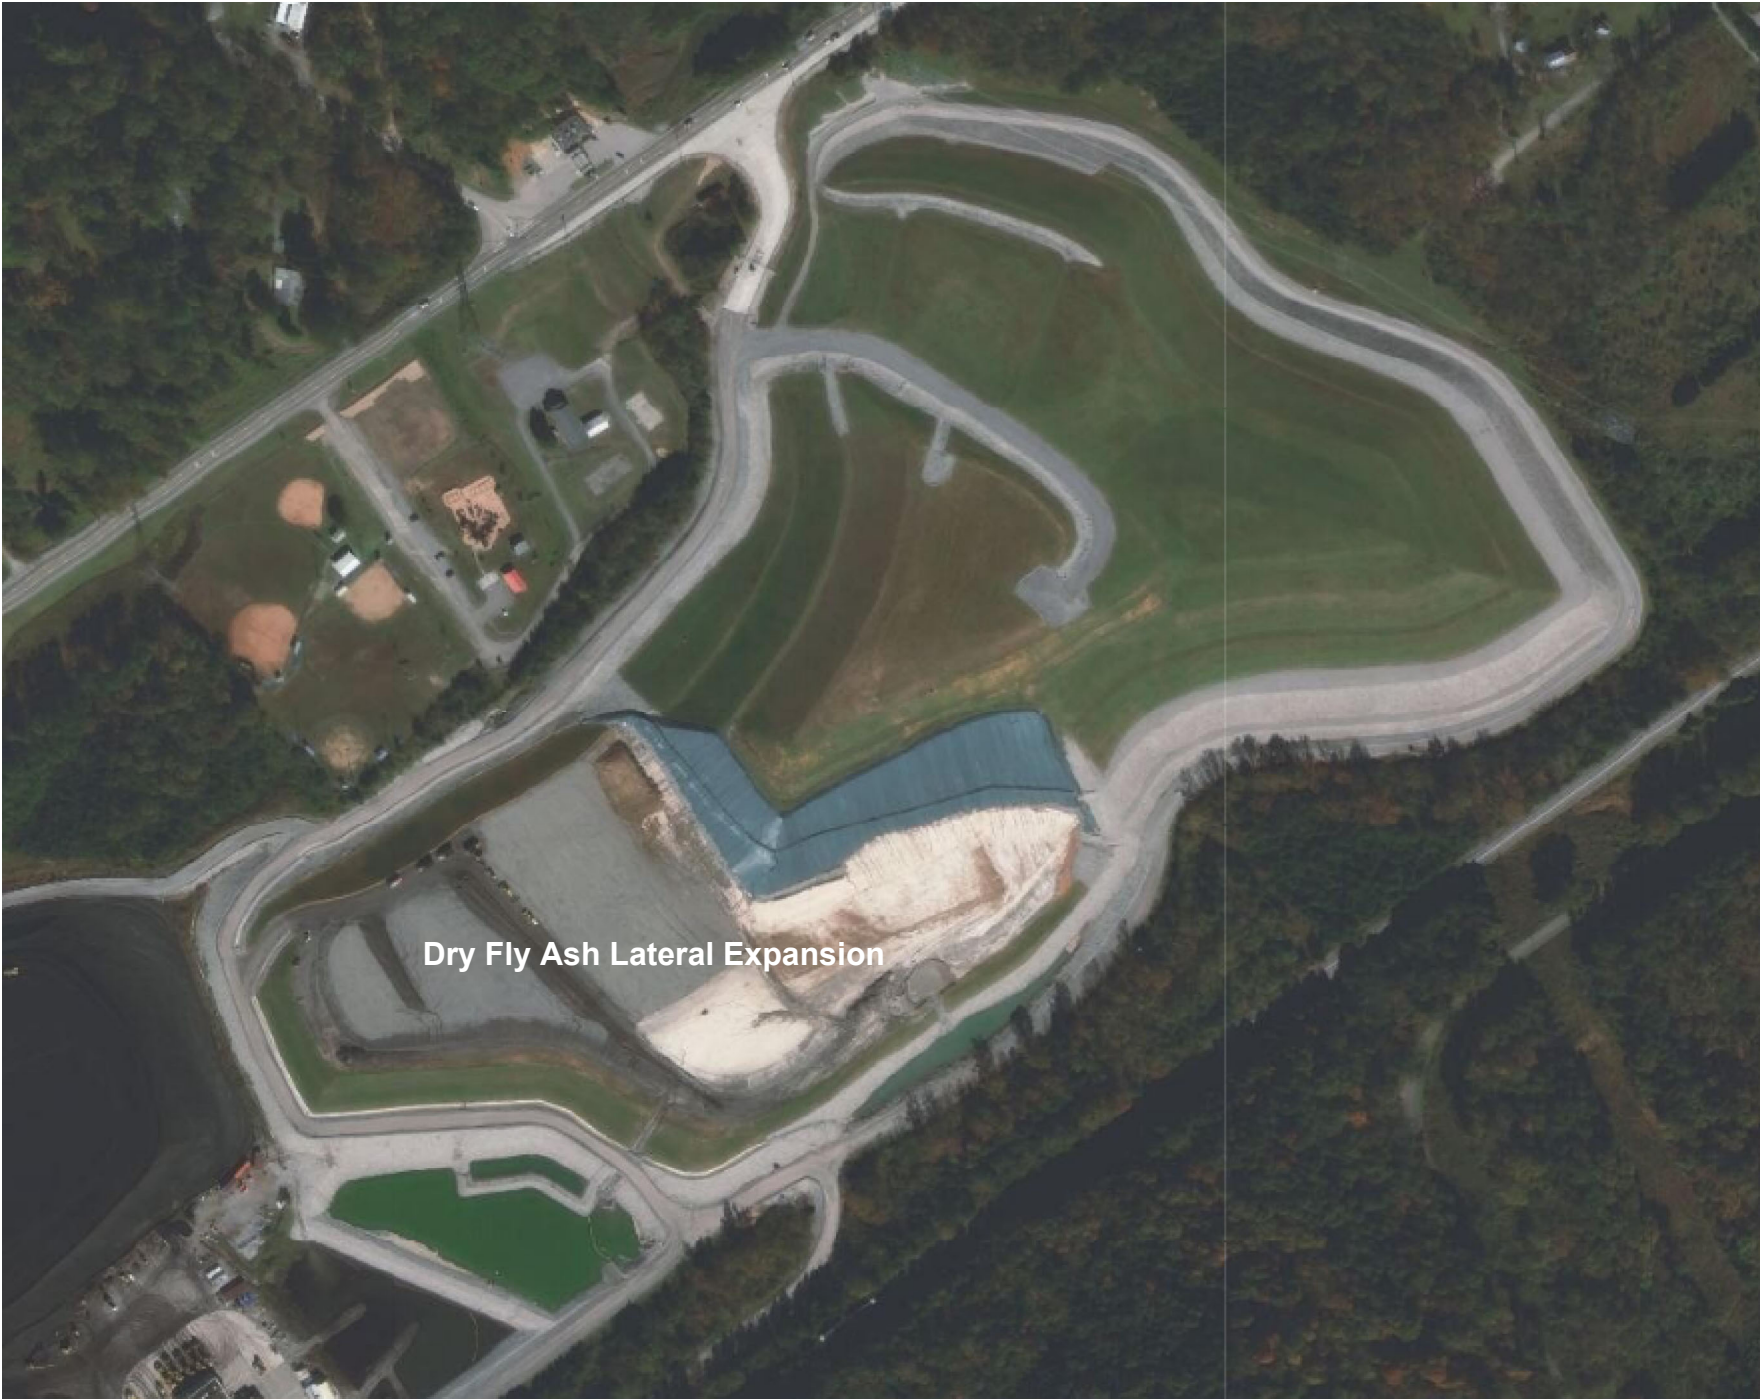
Dry Fly Ash Lateral Expansion

9. Active construction to construct a internal drainage feature (South Toe Drain).

10D & 12B. No significant erosion.

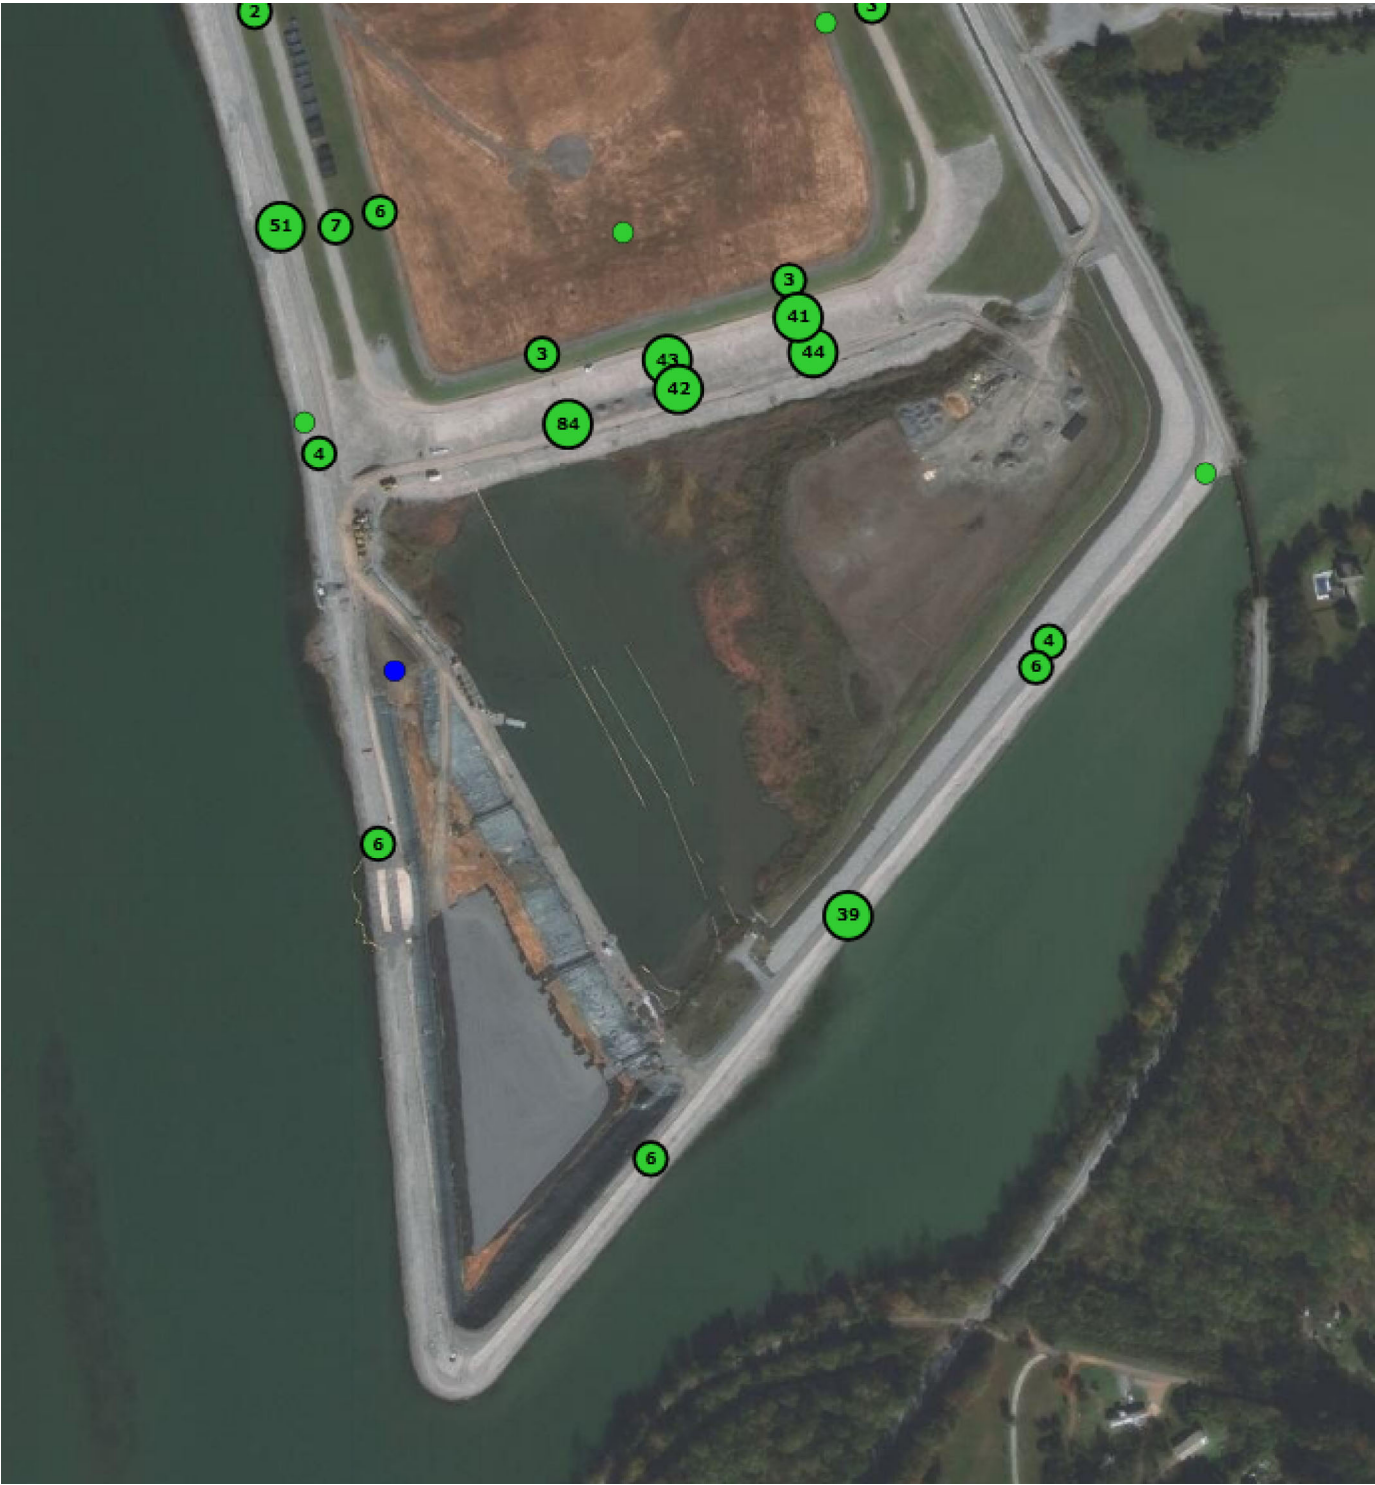
2020 BRF Annual Inspection - Main Ash Pond (Stilling Pond 2C, and Sluice Channel)

9 - Construction in progress at Main Ash Pond. Stilling Pond 2C is being repurposed into Process Water Basin 1. Construction is approximately 80% completed.

11A&B - By observation it appears there is greater than 5' of FB. Process water flows are conveyed to the Main Ash Pond and overflows pumped to the Clinch River which construction is in process at PWB1.

11C - Staff gauge not in service while construction is in progress.

16A-E - Principal and Emergency spillways nearing the end of construction at PWB1.
