**Initial Structural Stability Assessment
Stilling Pond 2C and Sluice Channel
EPA Final CCR Rule
TVA Bull Run Fossil Plant
Clinton, Tennessee**

**Initial Structural Stability Assessment
40 CFR 257.73(d)(1)
Existing CCR Surface Impoundments
TVA Bull Run Fossil Plant**

**Initial Structural Stability Assessment
for Riser Structures in Stilling Pond 2C
at TVA Bull Run Fossil Plant**

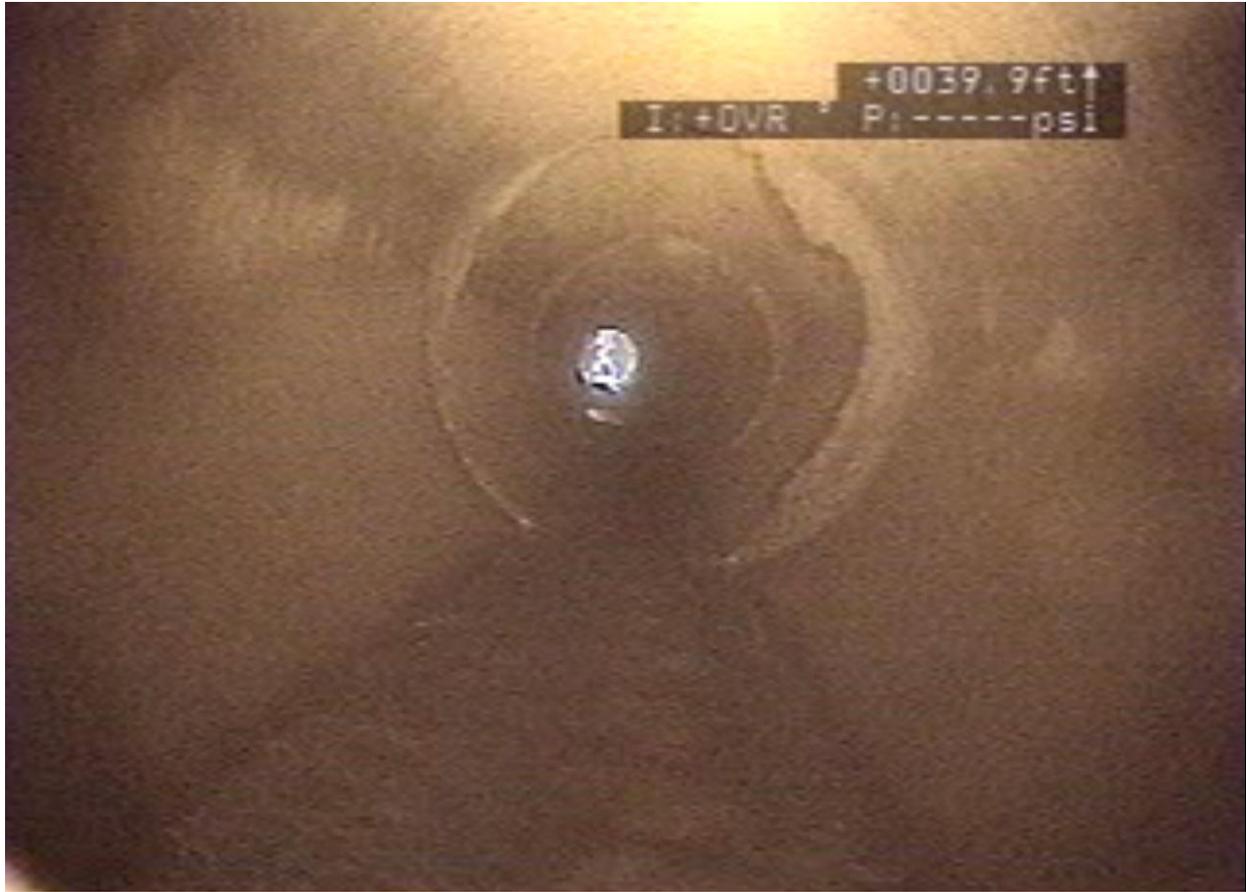
The existing outlet pipes under the perimeter dike between Stilling Pond 2C and the Clinch River have been inspected via camera. The video inspection was completed prior to the spillway modification project completed in 2011. The interior of the outlet pipes were generally in good condition with some minor to moderate deposit encrustation (see **Appendix B** showing an image from the video inspection of the middle outlet pipe). Minimal joint leaking was also noted in the outlet pipes. Evaluation of the video recordings showed a clear pathway for the water flow without any significant obstruction or debris present inside the outlet pipes. Visual inspections of the dikes where pipes pass through do not show any signs of deformation. The pipes have been evaluated for buckling stability for two different limit states: usual loading conditions associated with regularly occurring pool levels and unusual loading conditions associated with the design flood event. All associated calculations, including the structure's geometry and material properties are included in **Appendix A**. The pipes satisfy the stability checks for the limit states considered. Also, in the Stilling Pond Closure Plan (AECOM drawing 10W524-09), the outlet pipes will be slip lined using cured-in-place (CIPP) lining. The liner will seal the pipe joints and add a layer of protection against leakage.

Image 1. Video inspection of outlet pipe from middle riser in Stilling Pond 2C, view looking towards spillway riser showing minor encrustation and minimal leaking.
