July 28, 2022

**FY2022 Engineering (Annual) Inspection of CCR Facilities
Cumberland Fossil Plant
Cumberland City, Stewart City, TN**

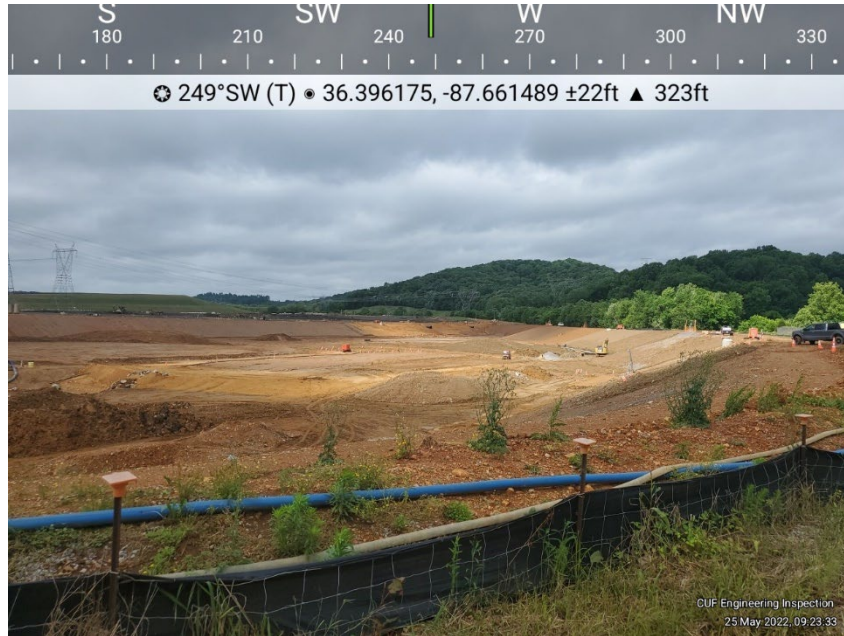
Photo B-1	View of the Stilling Pond (including Retention Pond). General conditions, no deficiencies observed.
------------------	---

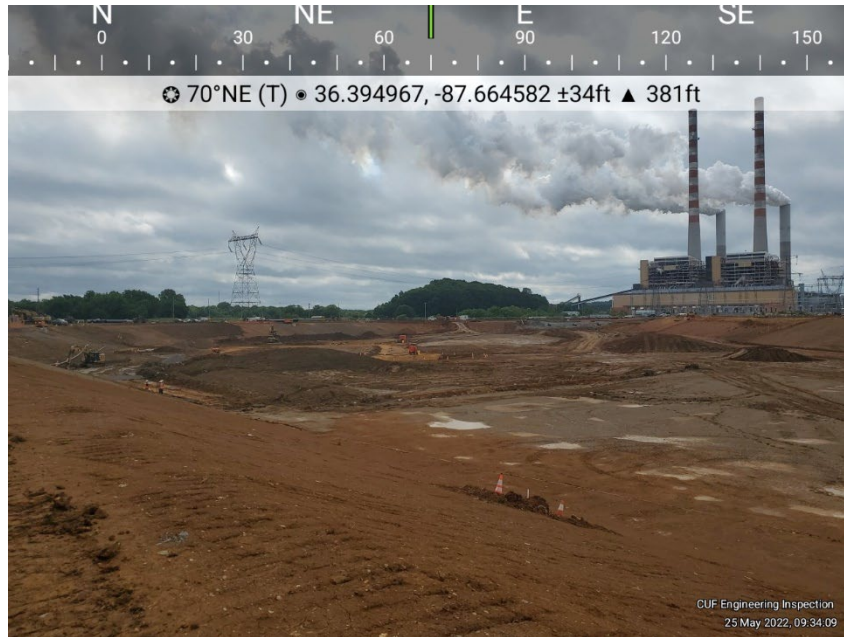
Photo B-2	View of the Stilling Pond (including Retention Pond). General conditions, no deficiencies observed.
------------------	---

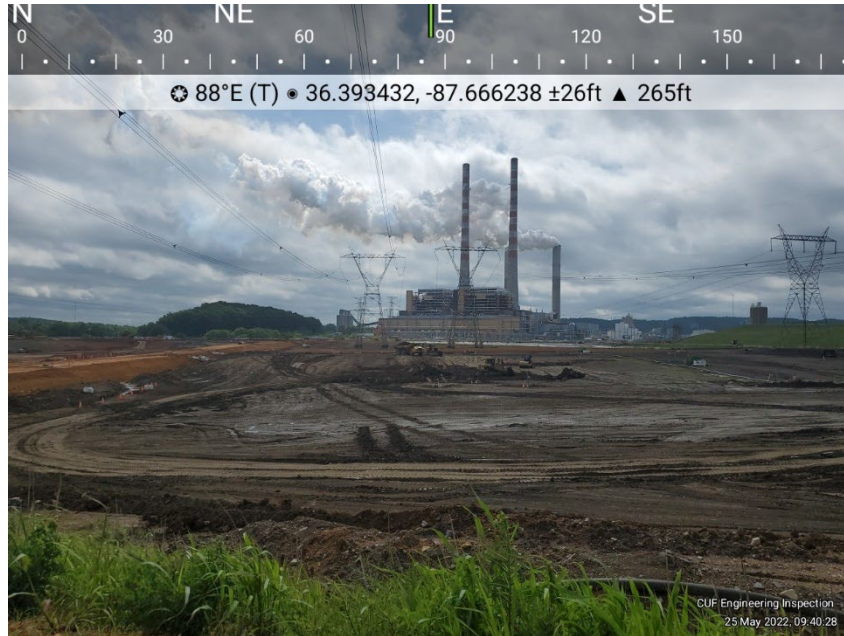
Photo B-3	Consolidated CCR materials in the Stilling Pond (including Retention Pond). General conditions, no deficiencies observed.
------------------	---

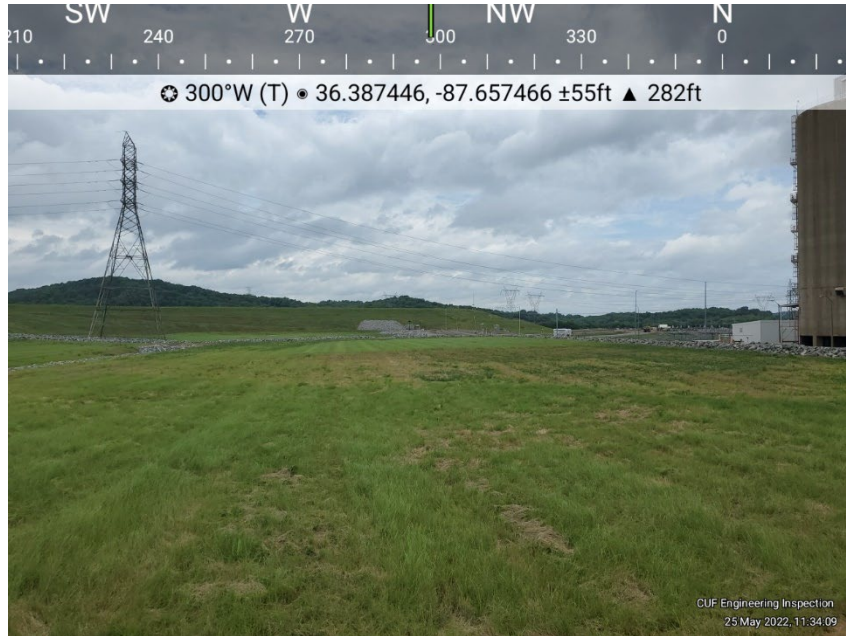
Photo C-1	View of the Bottom Ash Pond. General conditions, no deficiencies observed.
------------------	--

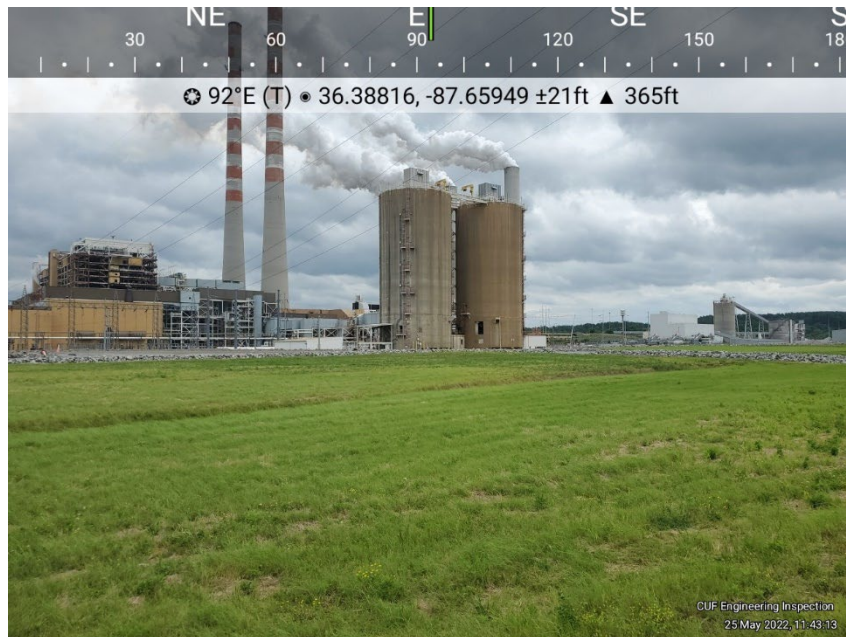
Photo C-2	View of the Bottom Ash Pond. General conditions, no deficiencies observed.
------------------	--

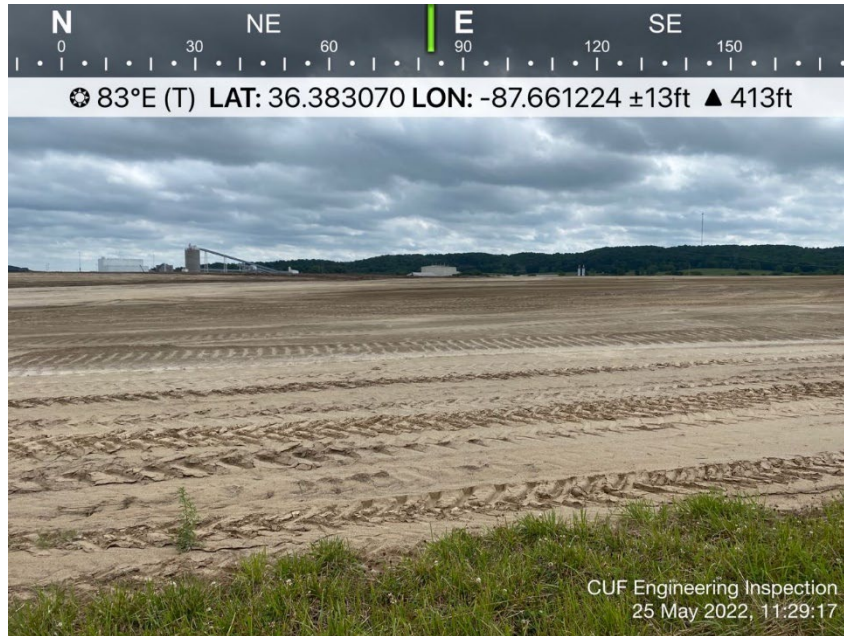
Photo D-1	View of top interior of the Gypsum Storage Area. General conditions, no deficiencies observed.
------------------	--

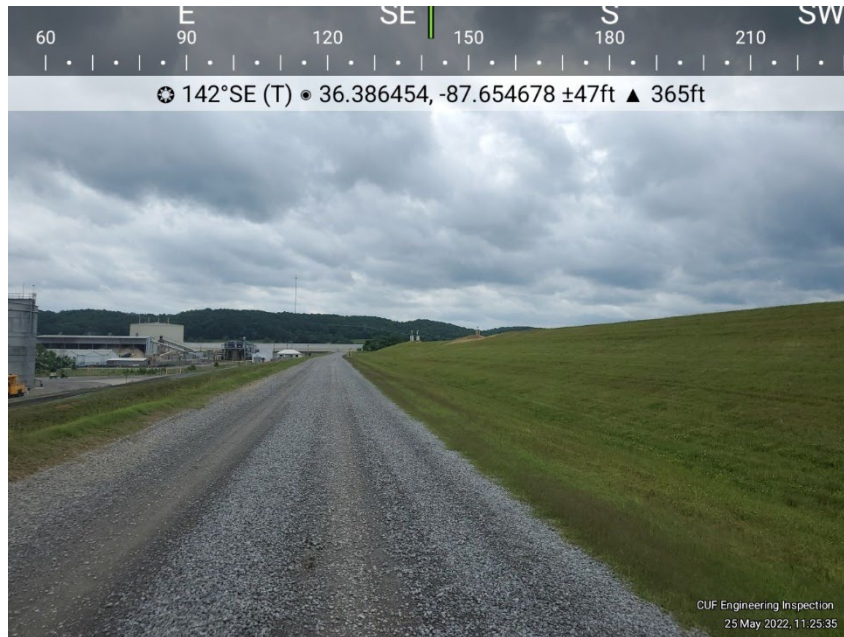
Photo D-2	View of northern dike of the Gypsum Storage Area. General conditions, no deficiencies observed.
------------------	---

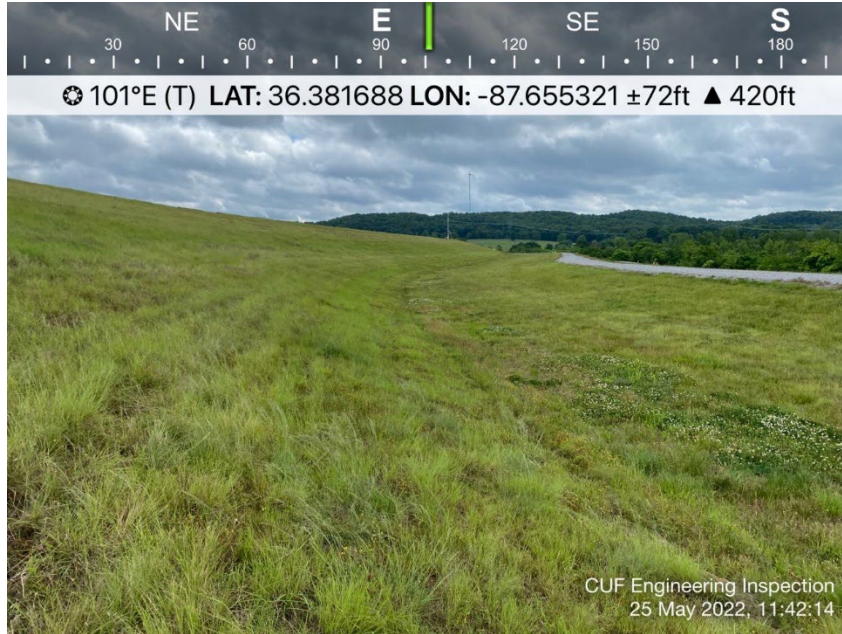
Photo D-3	View of southern exterior slope of the Gypsum Storage Area. General conditions, no deficiencies observed.
------------------	--

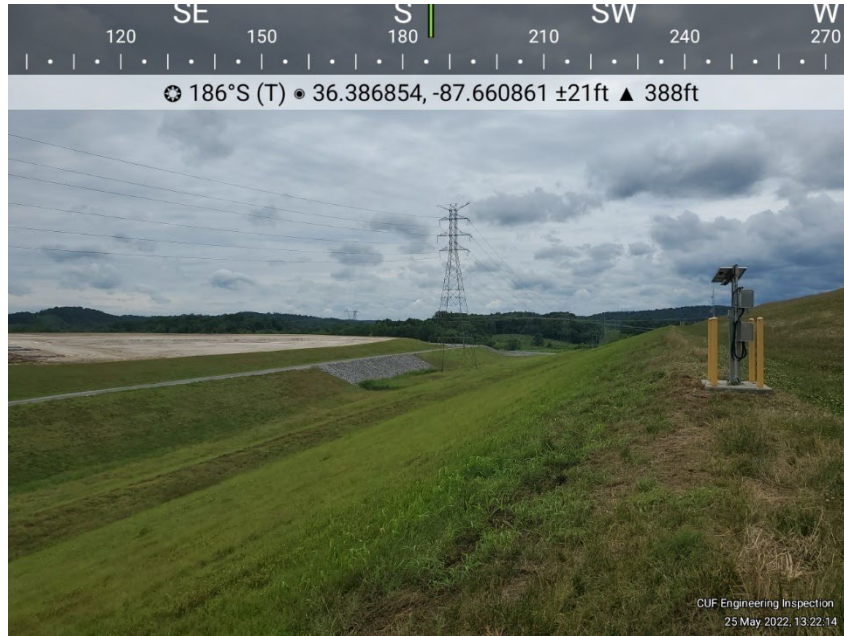
Photo E-1	View of the southeastern exterior slope of the Dry Ash Stack. General conditions, no deficiencies observed.
------------------	---

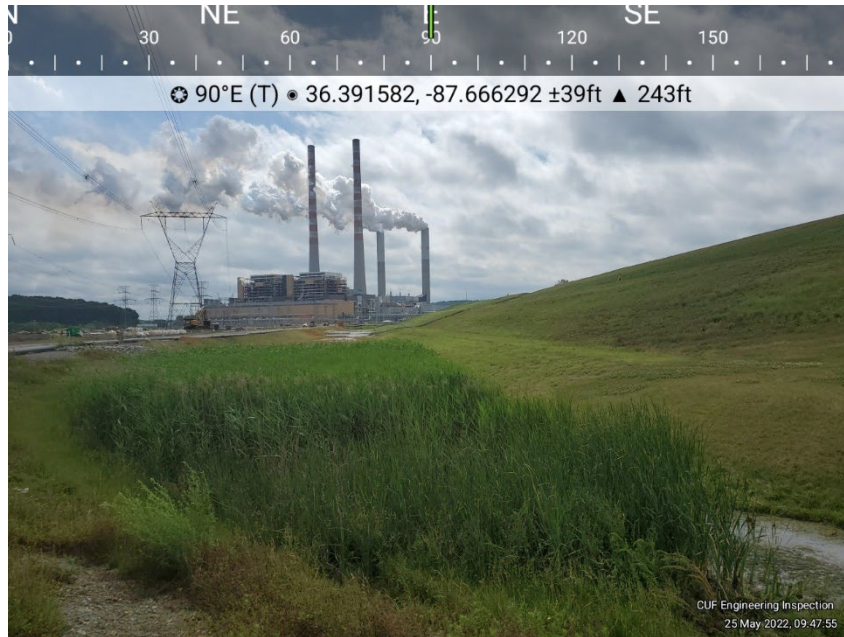
Photo E-2	View of the northern perimeter ditch at the toe of the Dry Ash Stack. General conditions, no deficiencies observed.
------------------	---

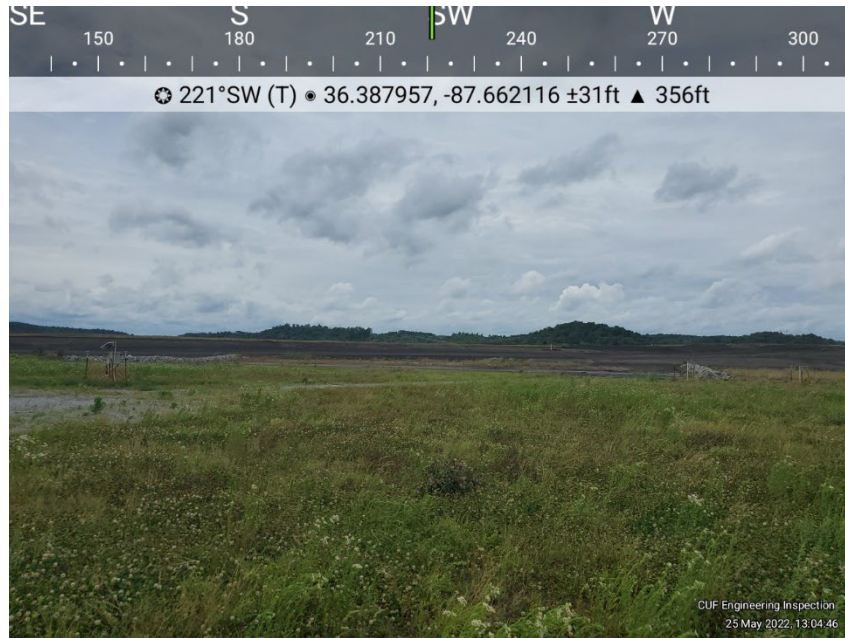
Photo E-3	View of interim covered interior portion of the Dry Ash Stack. General conditions, no deficiencies observed.
------------------	--

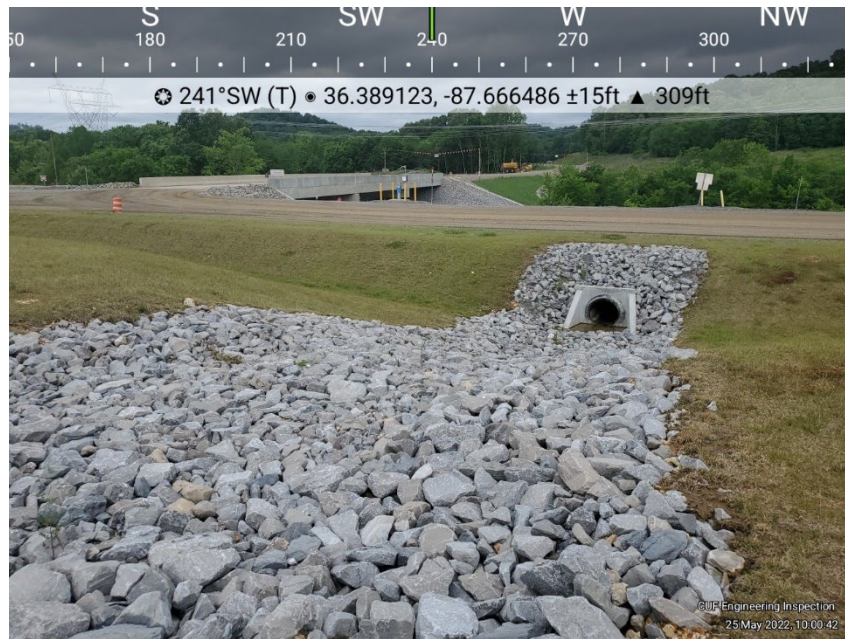
Photo E-4	Drainage feature connecting to perimeter road west of the Dry Ash Stack. General conditions, no deficiencies observed.
------------------	--
