December 18, 2020

**2020 Annual Inspection of CCR Facilities
Gallatin Fossil Plant
Gallatin, Sumner County, Tennessee**

The 2020 Annual Inspection of CCR facilities at Tennessee Valley Authority's (TVA's) Gallatin Fossil Plant (GAF) included review of the following structures:

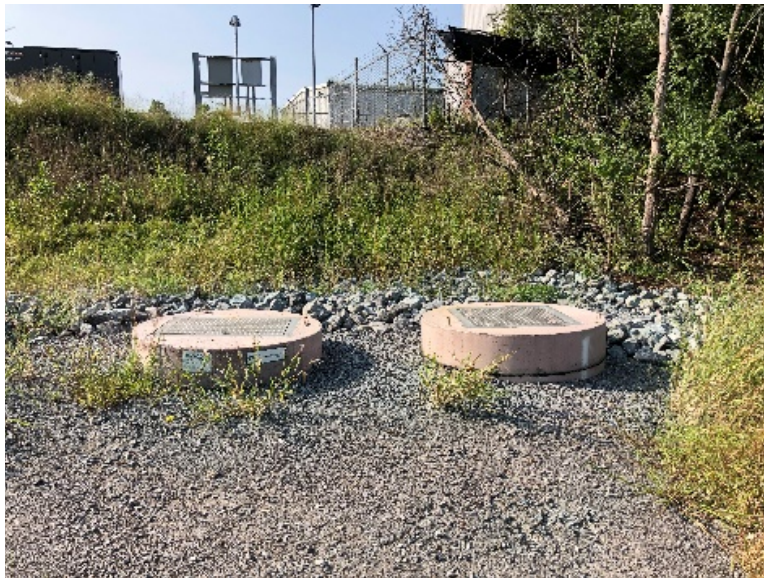
Photo 2	Collection system at Seep 13 at Ash Pond E. No deficiency pictured.
----------------	---

13A/14A - Construction of the collection system at Seep 13 was completed.

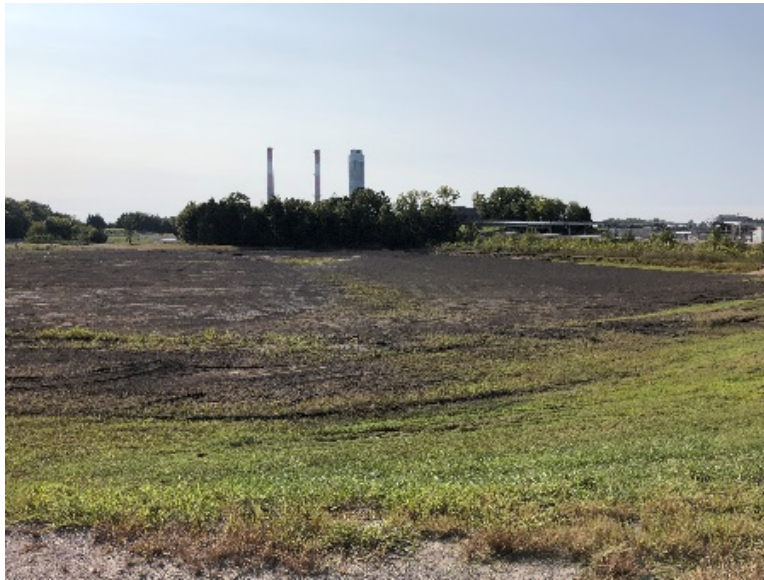
Photo 3

General view of Bottom Ash Pond looking southeast. No deficiency pictured.

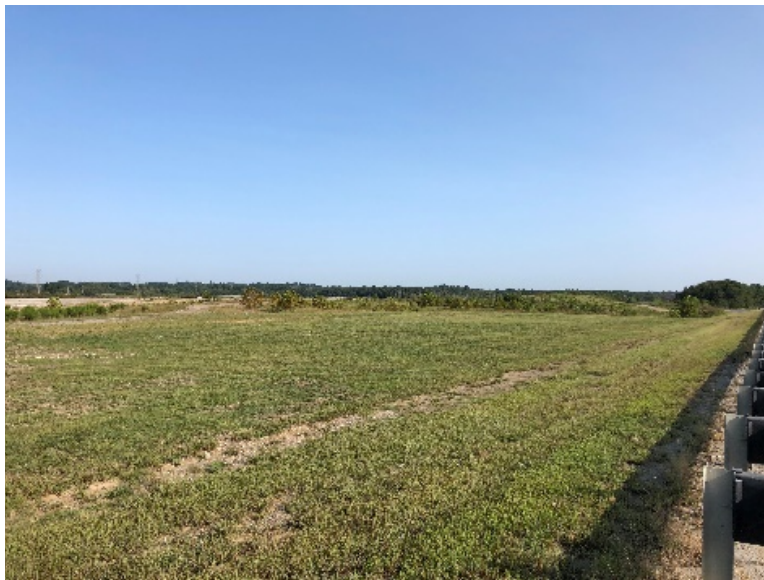
Photo 4

General view of Middle Pond A looking north. No deficiency pictured.

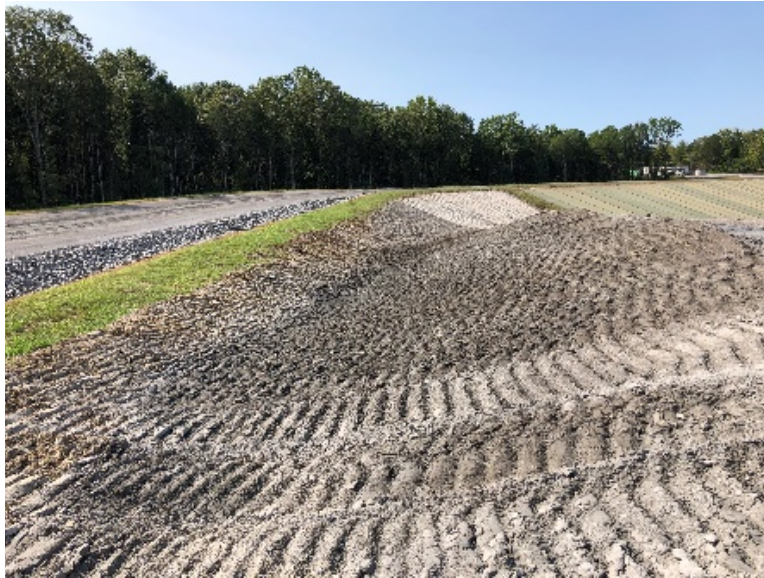
Photo 5

General picture of stacking area at North Rail Loop Landfill Cell 1 looking southwest. No deficiency pictured.

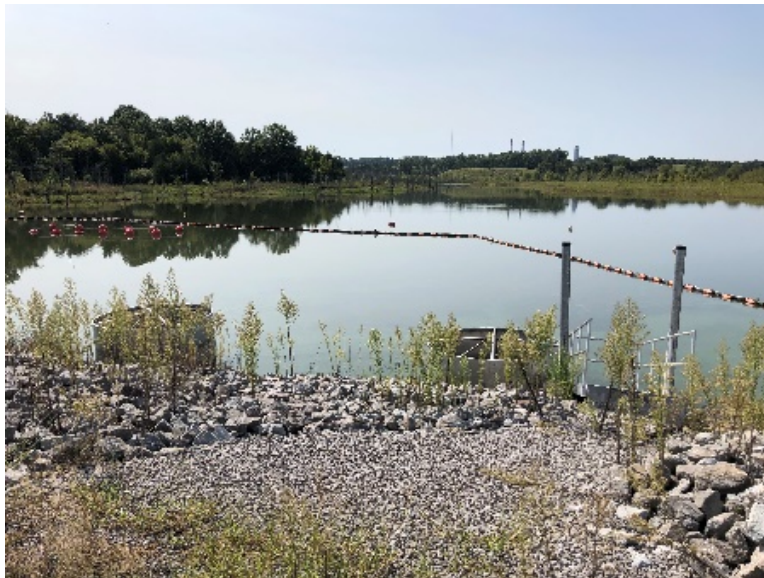
Photo 6

General view of Ash Pond A looking south. No deficiency pictured.
