December 18, 2020

**2020 Annual Inspection of CCR Facilities
Gallatin Fossil Plant
Gallatin, Sumner County, Tennessee**

**Gallatin Fossil Plant (GAF) 2020 Annual Inspection
Photo Log**

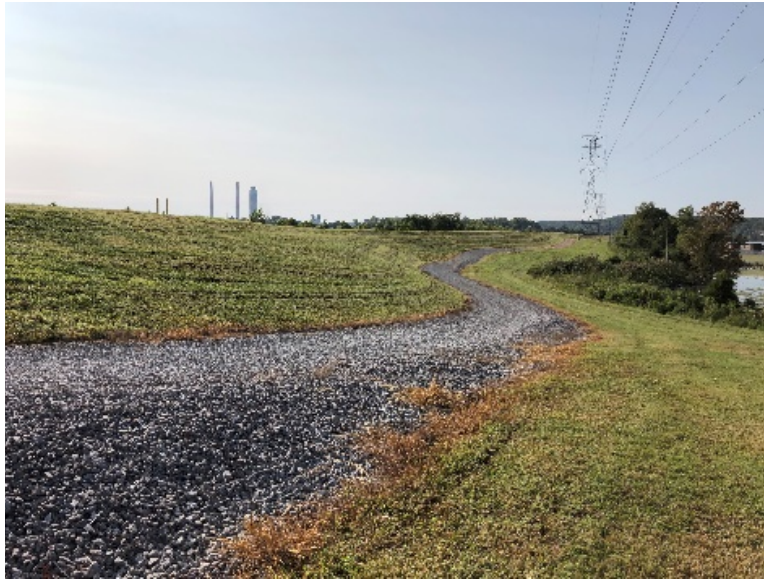
Photo 1	General view of perimeter dike at Ash Pond E looking south. No deficiency pictured.
----------------	---

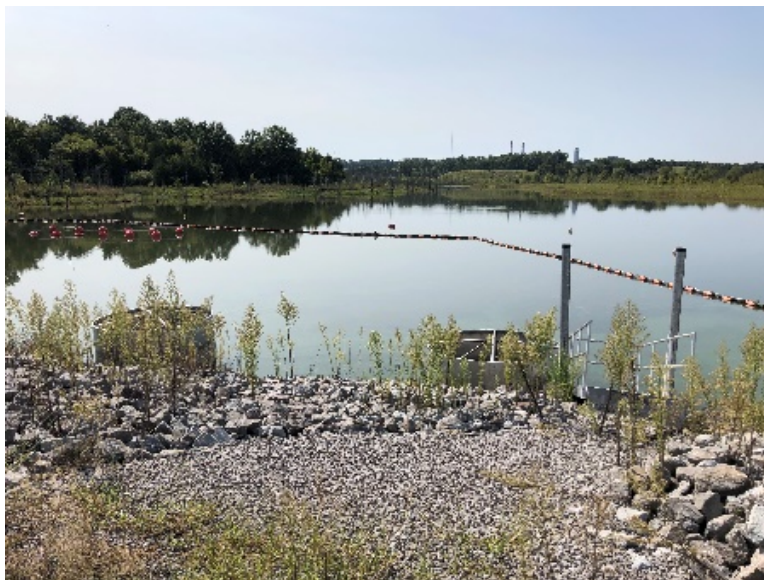
Photo 6

General view of Ash Pond A looking south. No deficiency pictured.
