July 29, 2021

**2021 Annual Inspection of CCR Facilities  
Gallatin Fossil Plant  
Gallatin, Sumner County, Tennessee**

**Gallatin Fossil Plant (GAF) 2021 Annual Inspection  
Photo Log**

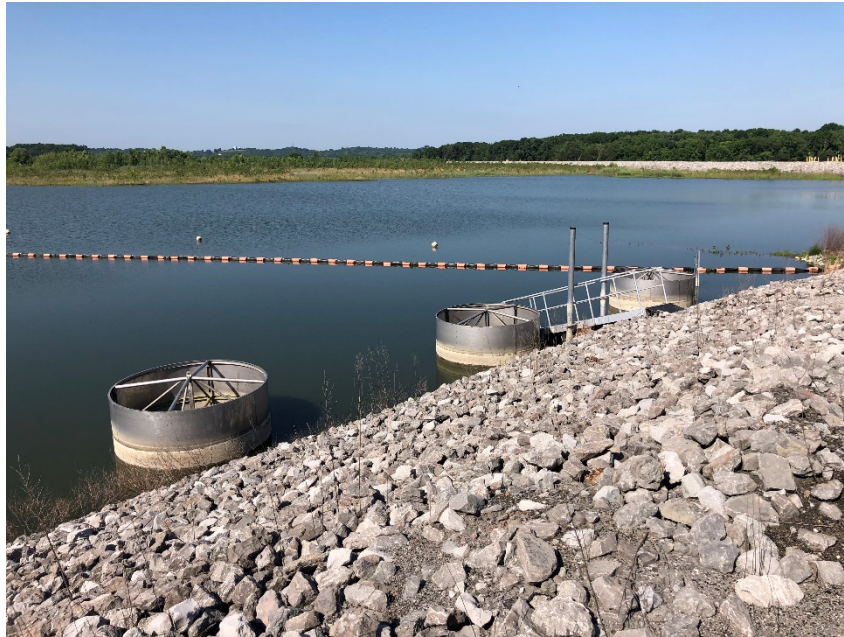
**Photo 1**

Minor leakage was observed in the spillway risers in Ash Pond A. It is recommended to monitor the structures and repair if conditions worsen.

17B - Minor leakage was observed in the spillway risers. It is recommended to monitor and repair if conditions worsen.

General view facing south of spillway risers at Ash Pond A. No deficiency pictured.

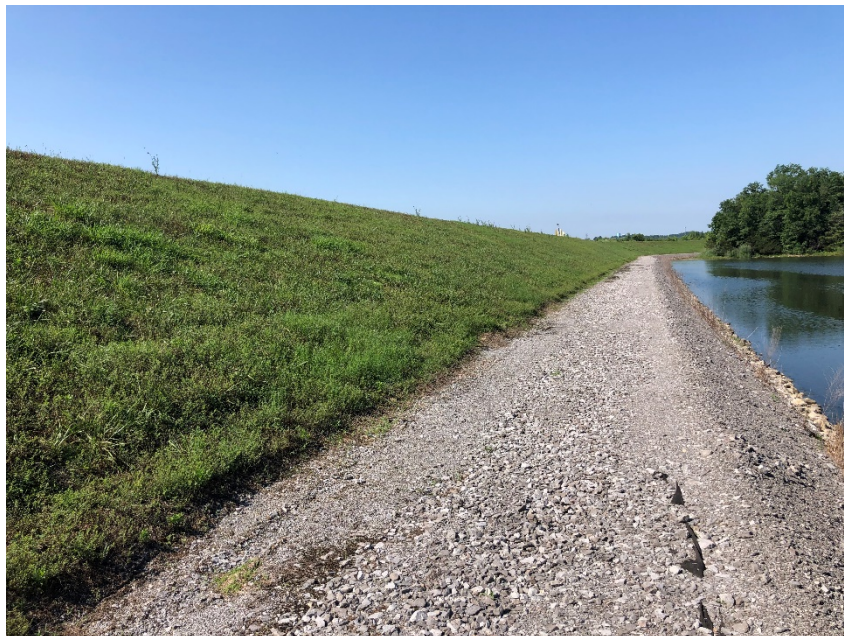
**Photo 2**

Typical view of exterior dike slope at Ash Pond A. No deficiency pictured.

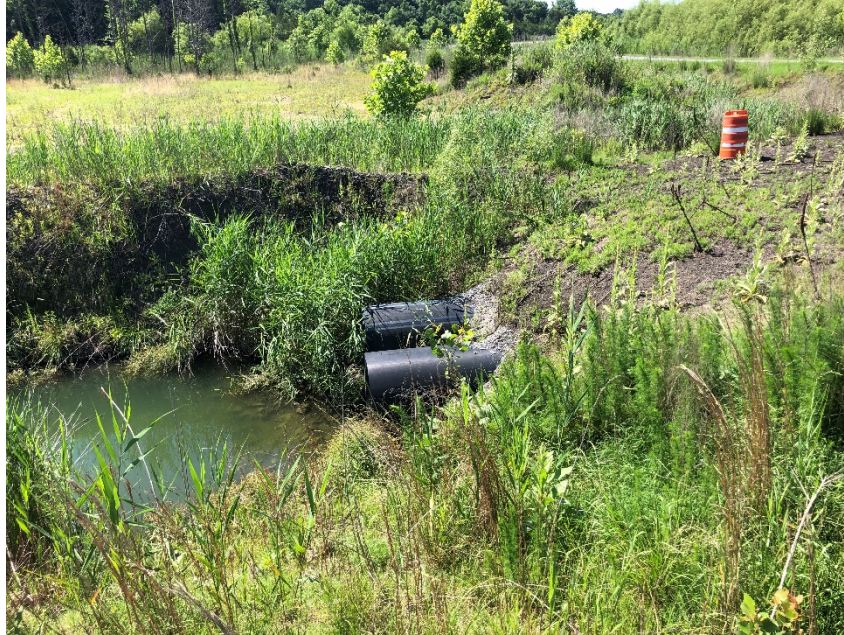
**Photo 3**

General view of outlet pipes from Middle Pond A into Ash Pond A. No deficiency pictured.

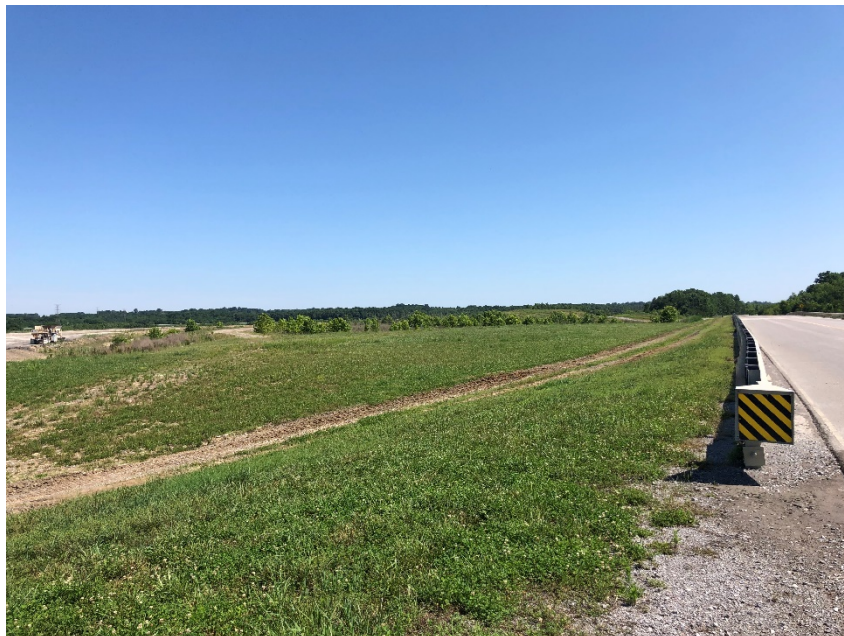
**Photo 4**

General view of Middle Pond A looking north. No deficiency pictured.

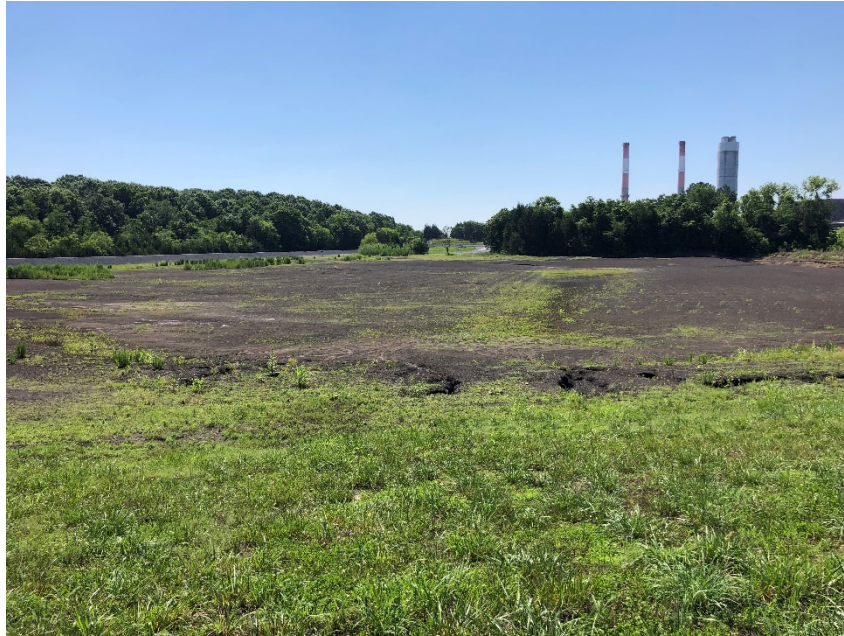
<b>Photo 5</b>	General view of Bottom Ash Pond looking south. No deficiency pictured.
----------------	--

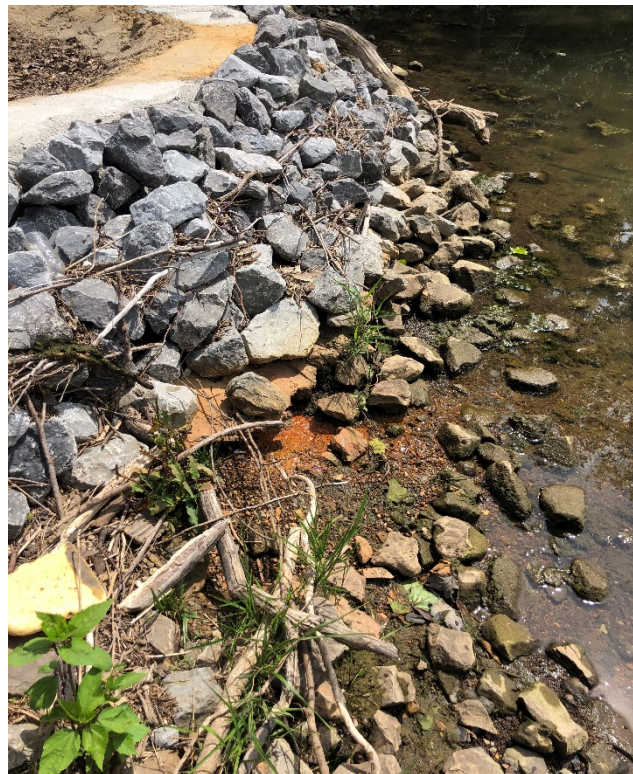
TVA observed seepage from the Seep 13 grouted cofferdam in May 2021. TVA has notified the Tennessee Department of Environment and Conservation and has initiated the activities required under the Seepage Action Plan. TVA is currently preparing the Corrective Action Plan to repair the collection system. During this inspection no seepage could be observed due to the elevated river level.

15A/16 - Seepage was observed from the Seep 13 grouted cofferdam in May 2021 and reported to TDEC. Seepage could not be observed during this inspection because of the river level. TVA is working on the plan to repair the collection system.

<b>Photo 6</b>	Seep 13 at Ash Pond E on May 27, 2021 to show observed seepage. This area could not be viewed during the Annual Inspection due to the elevated river level.
----------------	---

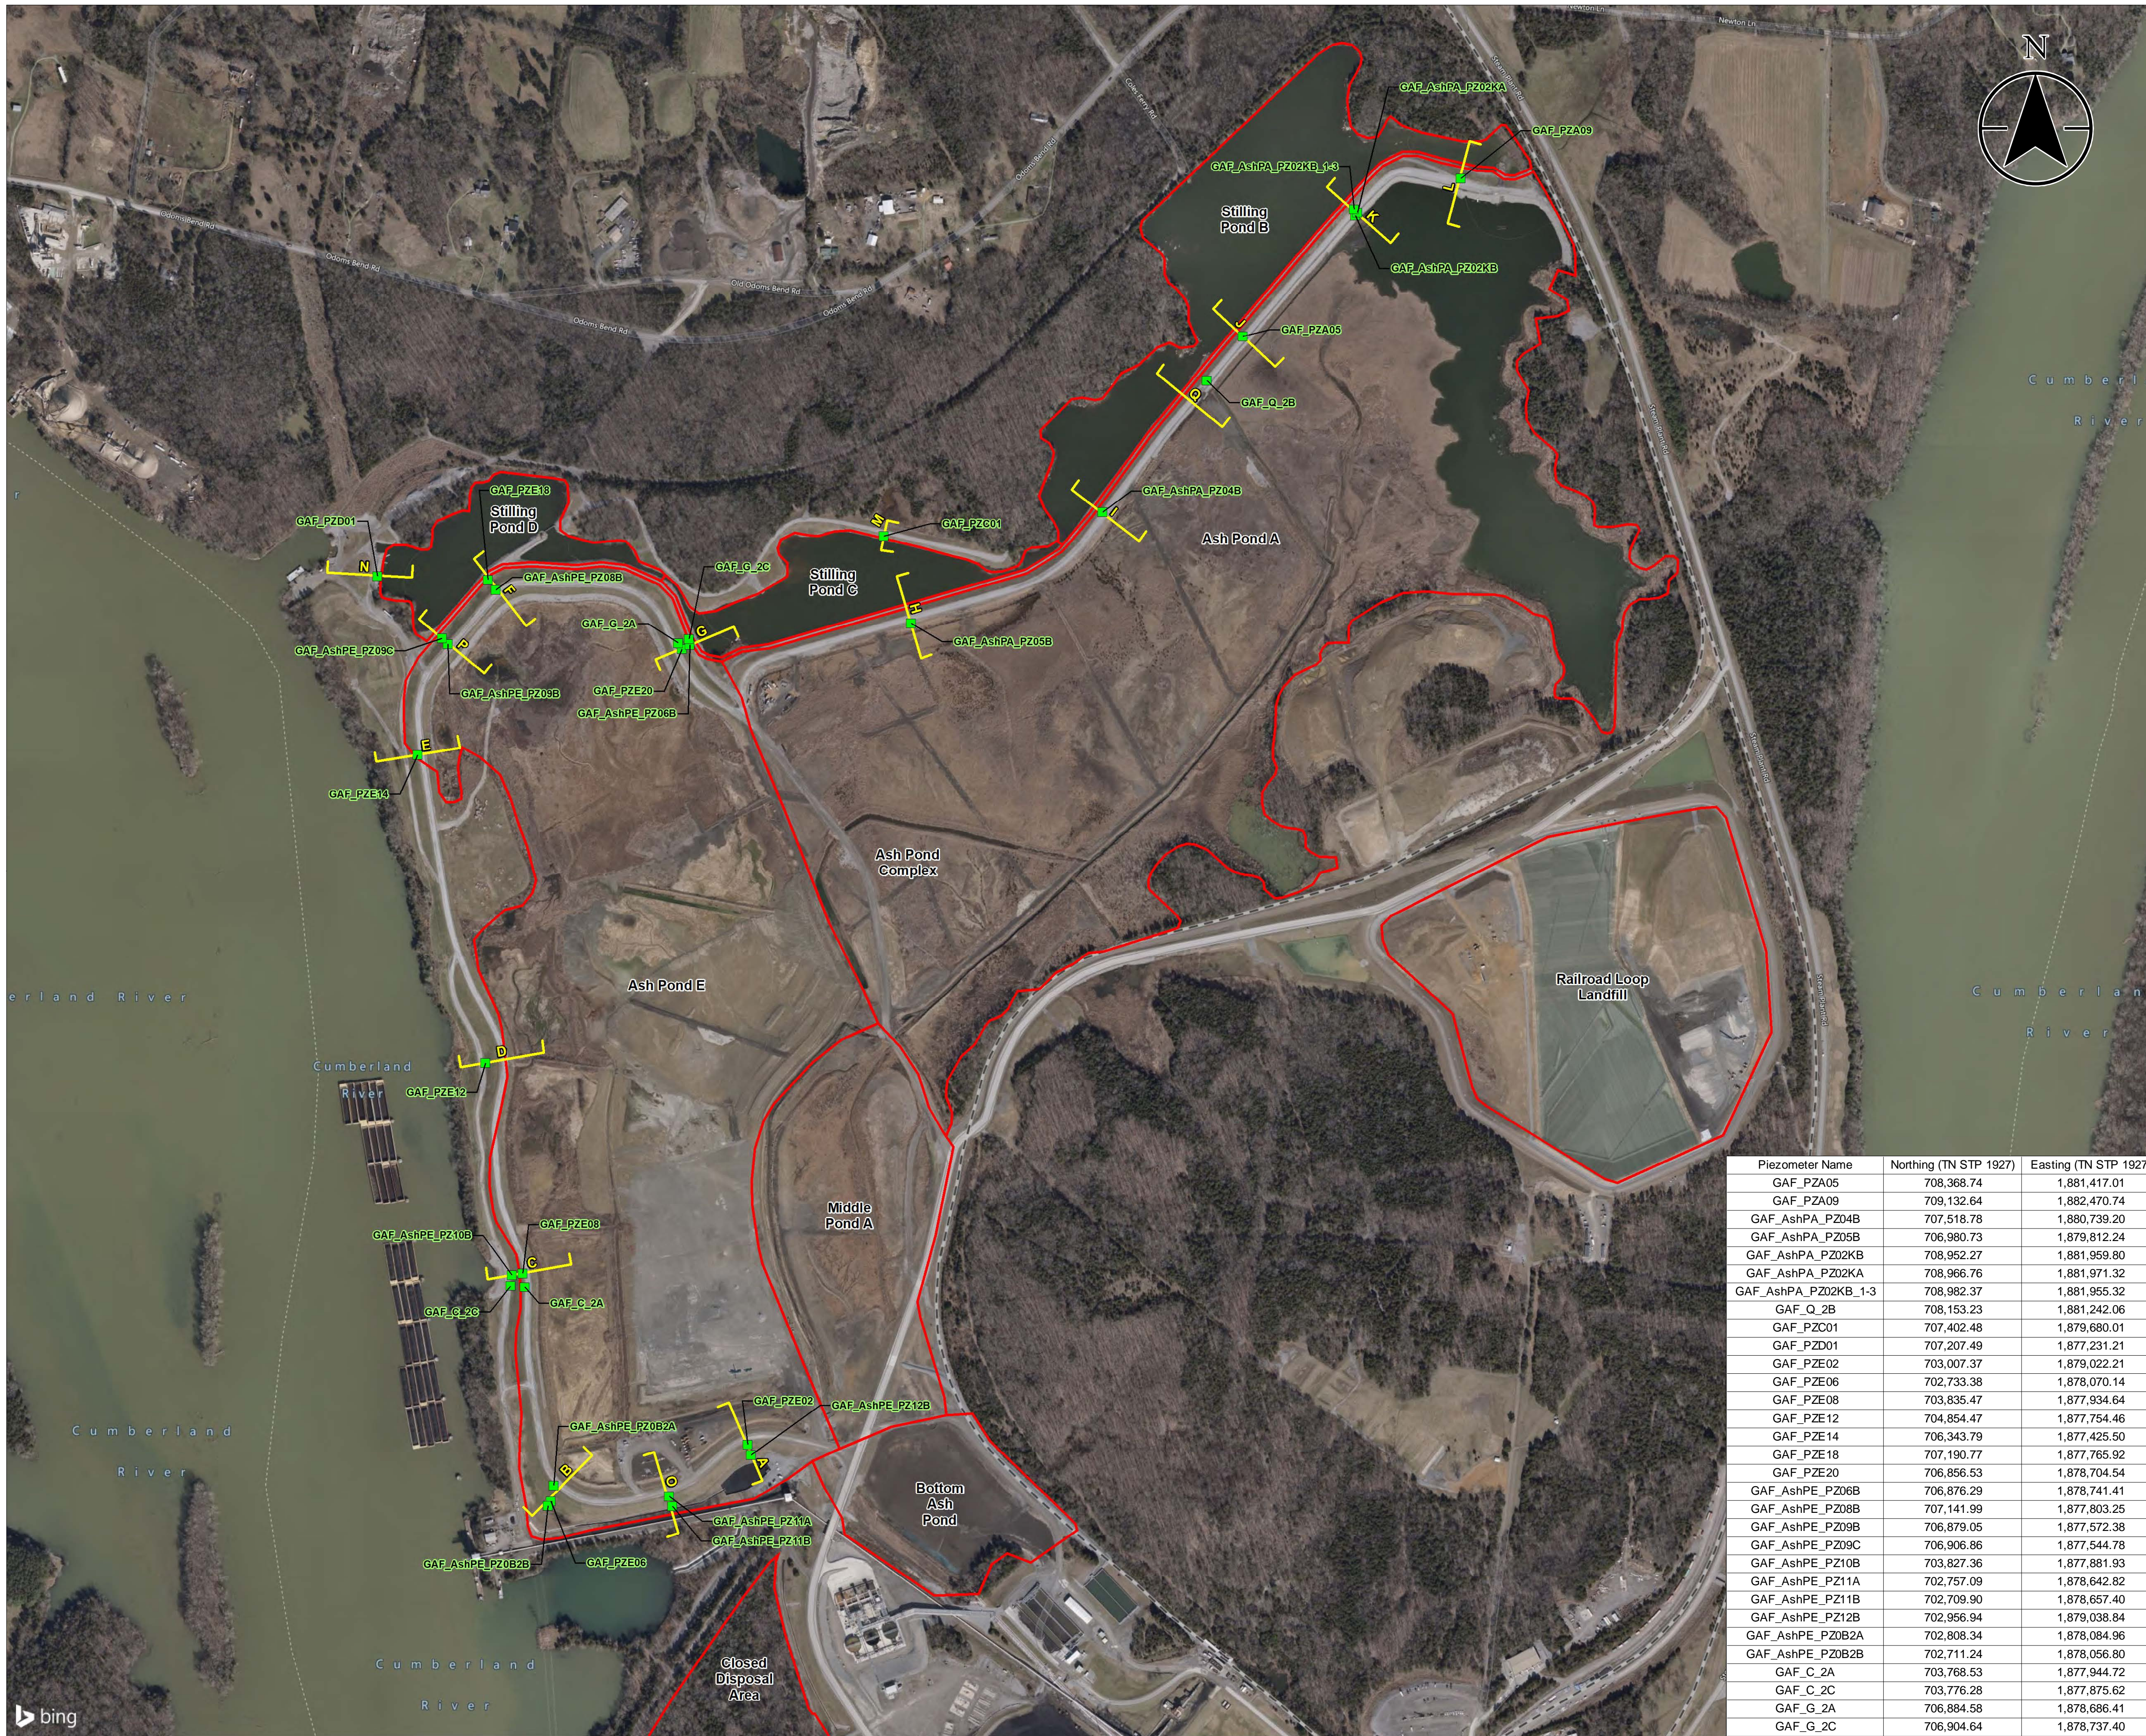
Figure No. 1  
 Title  
**GAF Instrumentation (as of 02/2021)**

The piezometer GAF\_G\_2C\_PZ4 at Ash Pond E is under evaluation by TVA. It is recommended that upon completion of the evaluation, TVA follow appropriate corrective actions to repair the instruments, if required.

19B - Piezometer GAF\_G\_2C\_PZ4 does not appear to be functioning correctly. It is recommended that TVA evaluate the sensors and make repairs as needed.
