**RE: Initial Structural Stability Assessment
Ash Pond Complex
EPA Legacy Coal Combustion Residuals (CCR) Rule
TVA Widows Creek Fossil Plant
Stevenson, Alabama**

Initial Structural Stability Assessment

Ash Pond Complex, Widows Creek Fossil Plant, Stevenson, Alabama

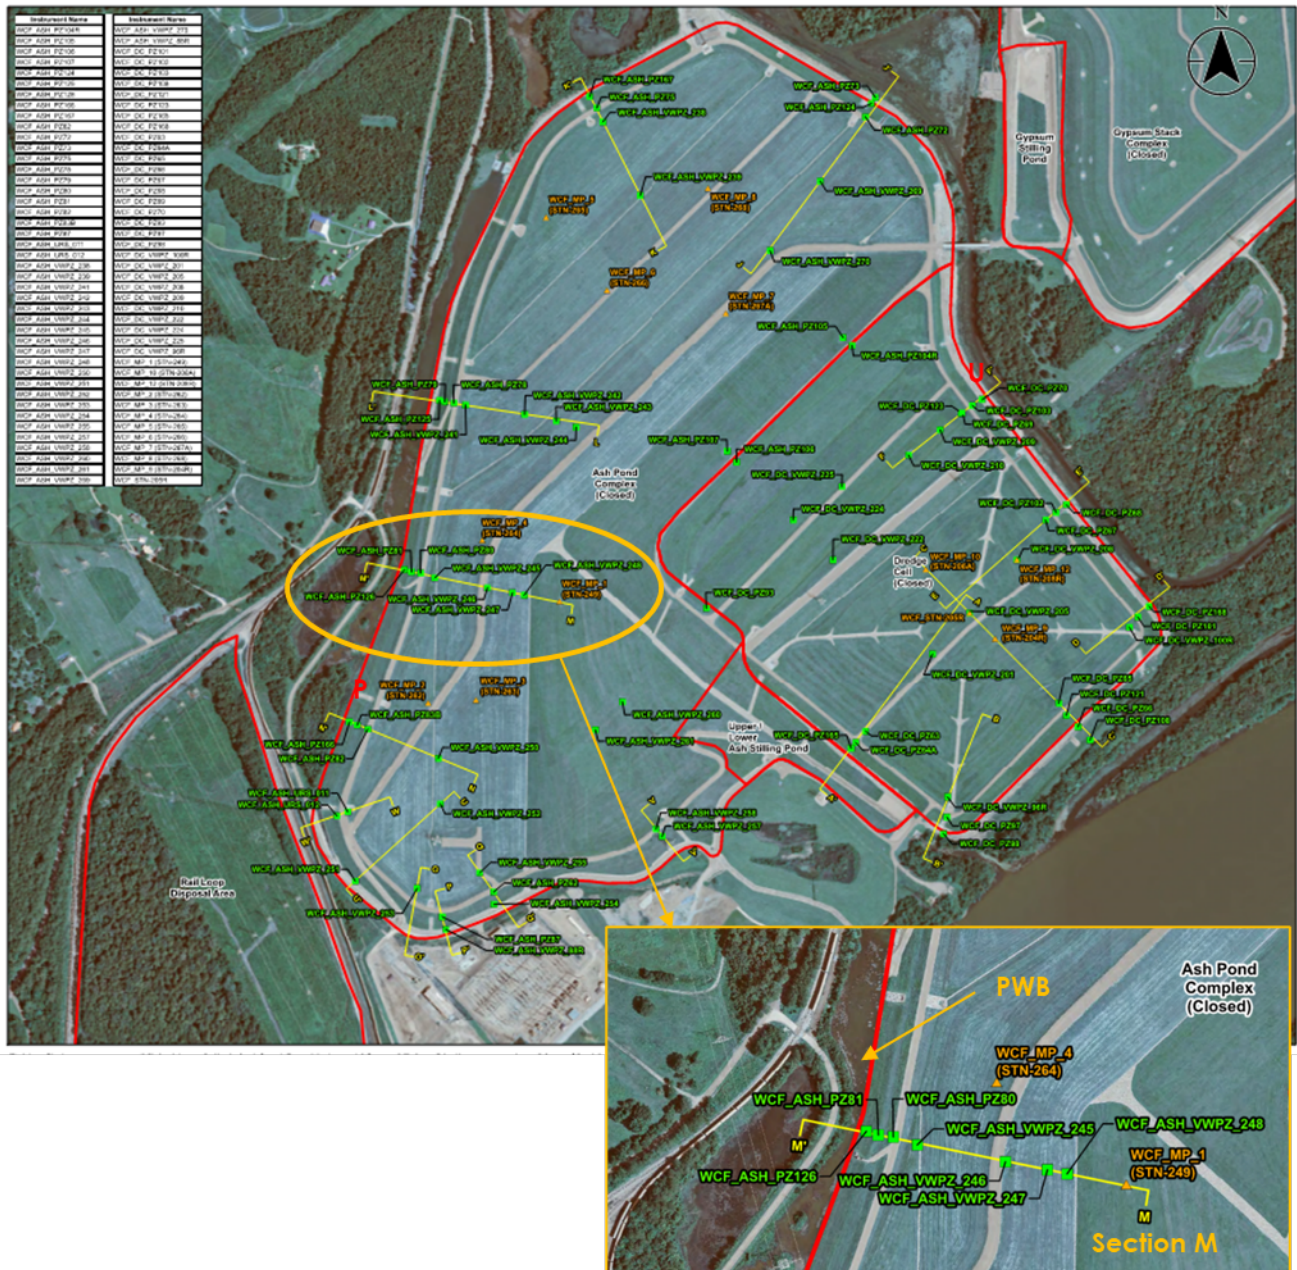
Figure 2. WCF Ash Pond Complex – Plan View of Cross Sections

Section M as shown below in Figure 2 was identified as the most representative cross section exhibiting this condition and was therefore selected as the critical section for sudden drawdown stability evaluation.
