**Engineer's Certificate of Wetlands Location Demonstration
Slag Ponds 2A and 2B, and Slag Stilling Pond 2C
EPA Final CCR Rule
TVA Paradise Fossil Plant
Drakesboro, Kentucky**

COAL COMBUSTION PRODUCT DISPOSAL PROGRAM

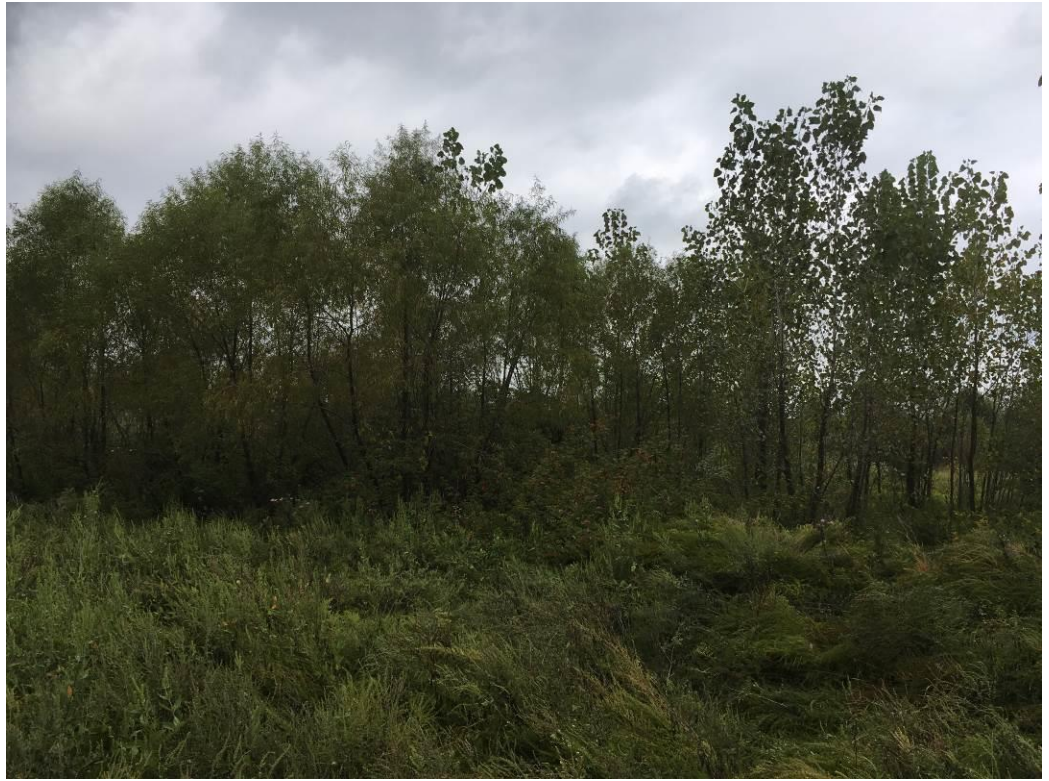
Photo No.
2

Wetland 27

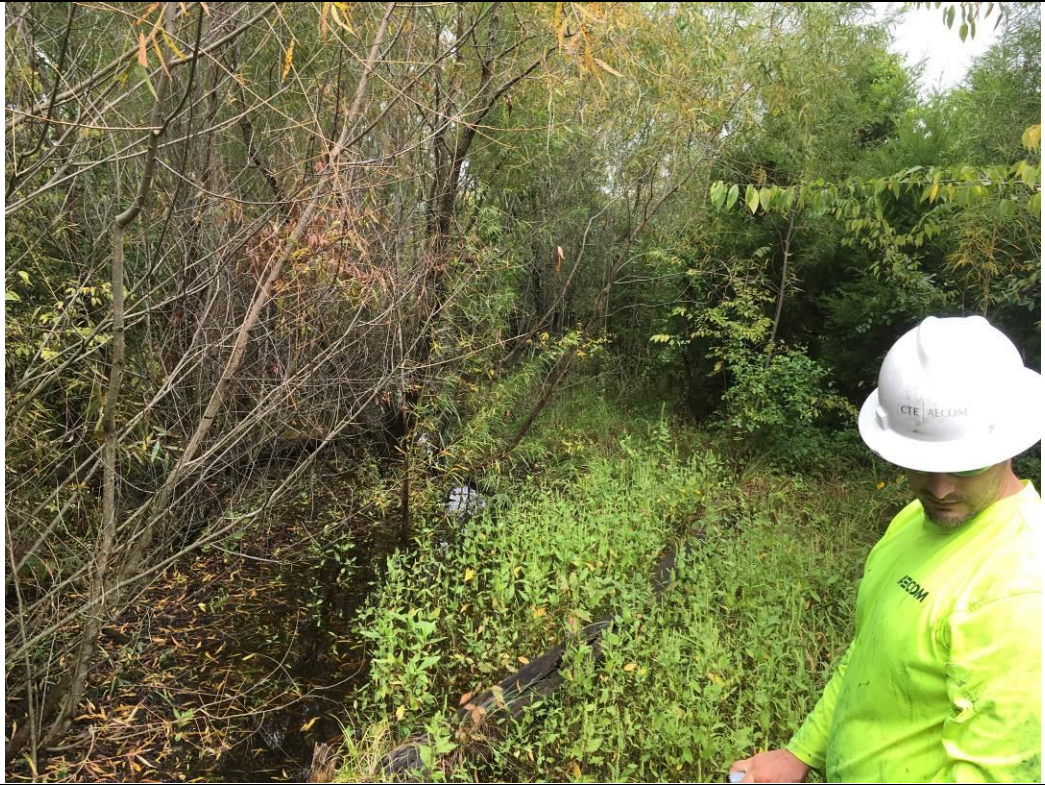
Photo No.
6

Linear Wetland 1 (LW1)
located in roadside ditch
east of Wetland 27

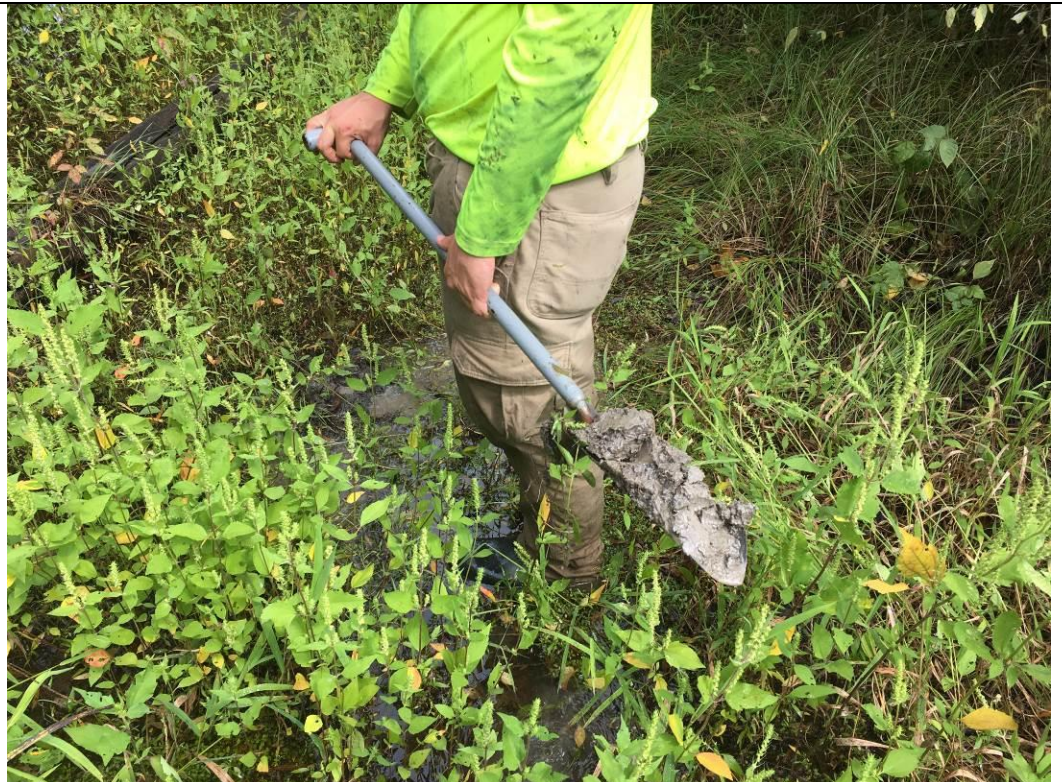
Soils in LW-1

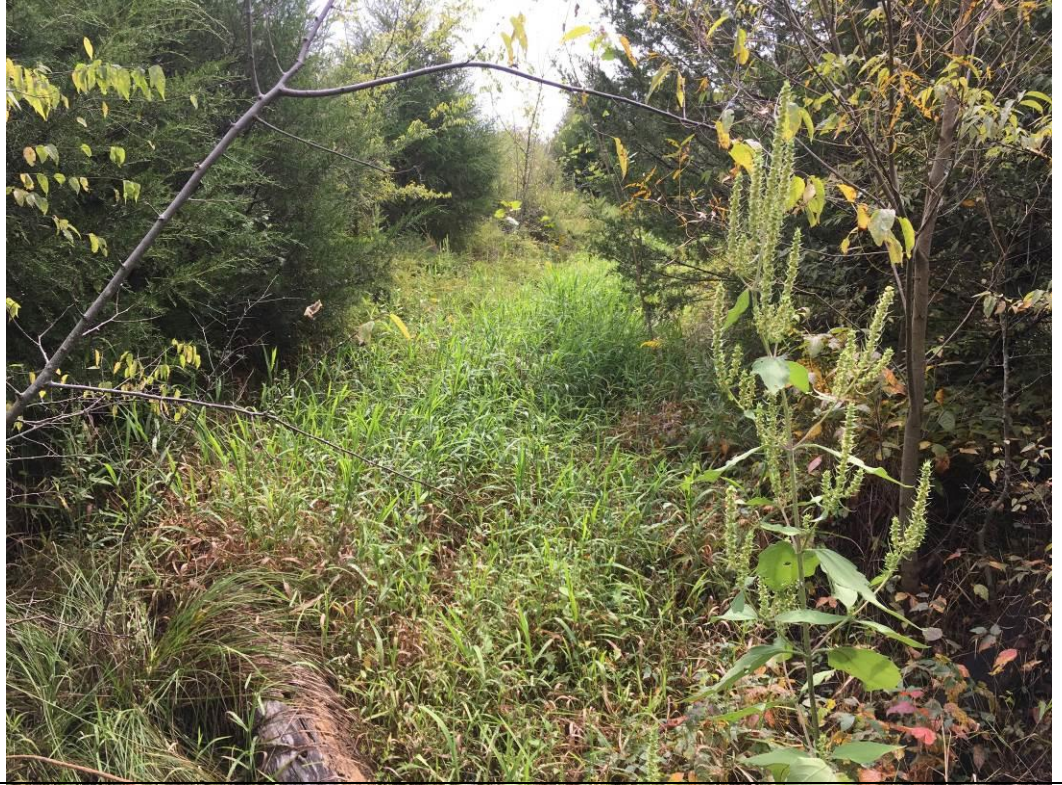
Photo No.
8

Upstream portion of LW-1

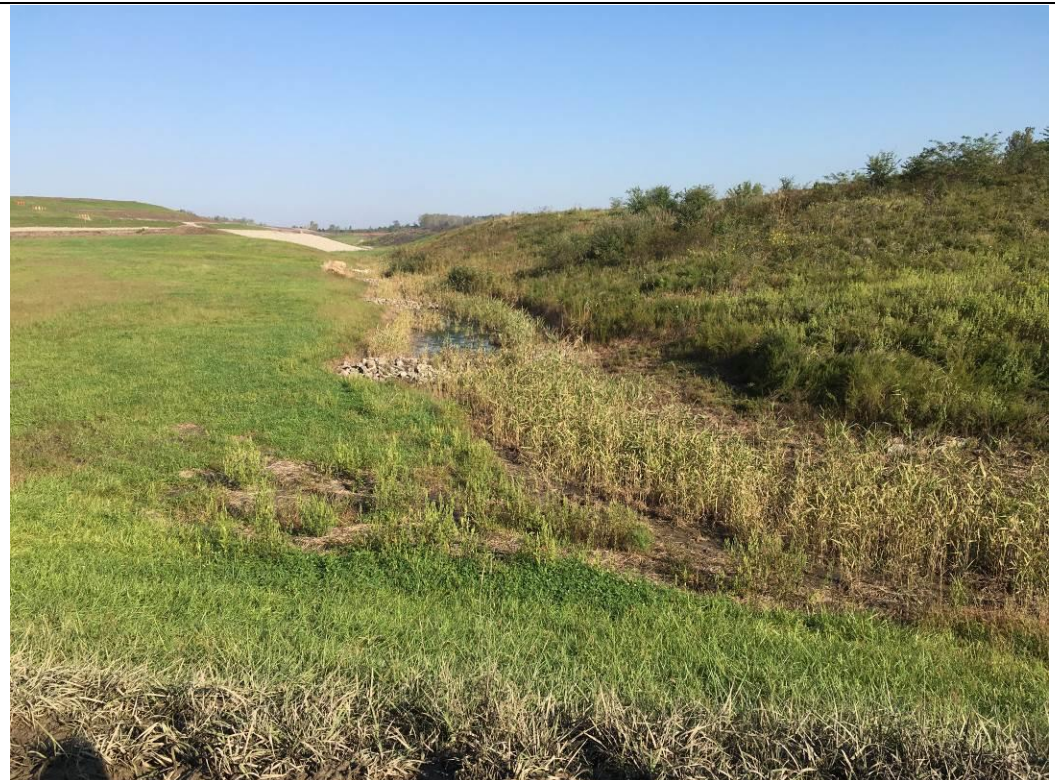
Leachate stream on east
side of Gyp Stack, part of
NPDES system, facing
north.

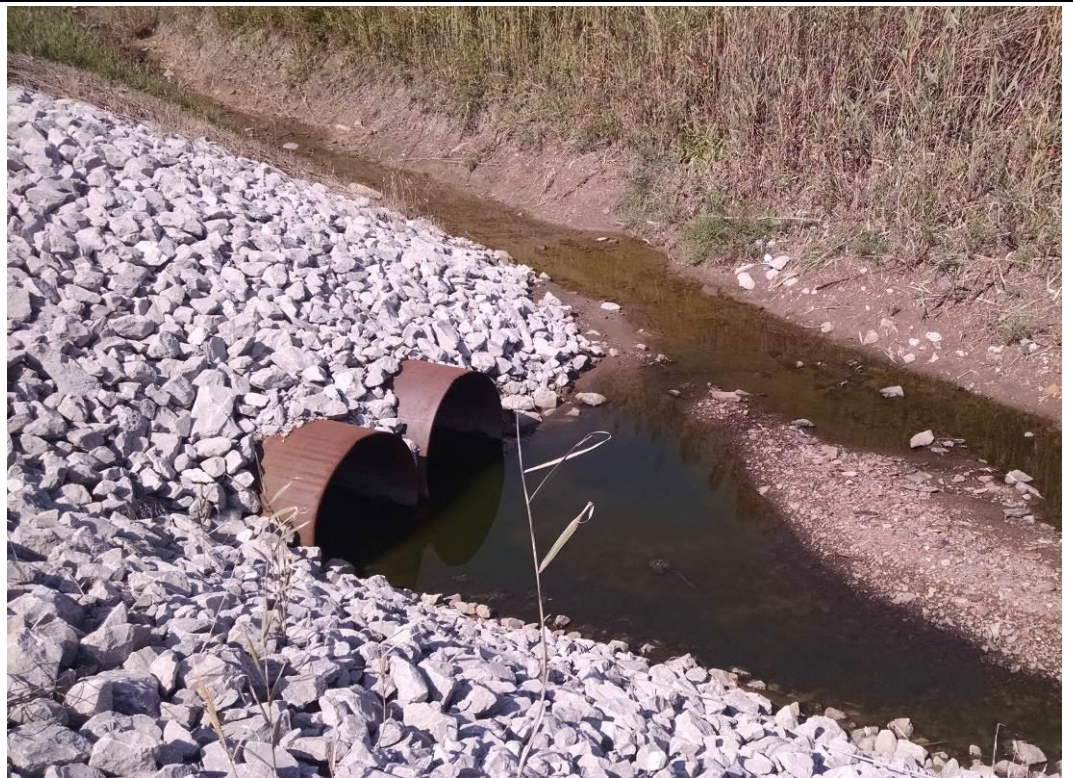
Overflow from retention
pond(culvert) joins with the
leachate stream.

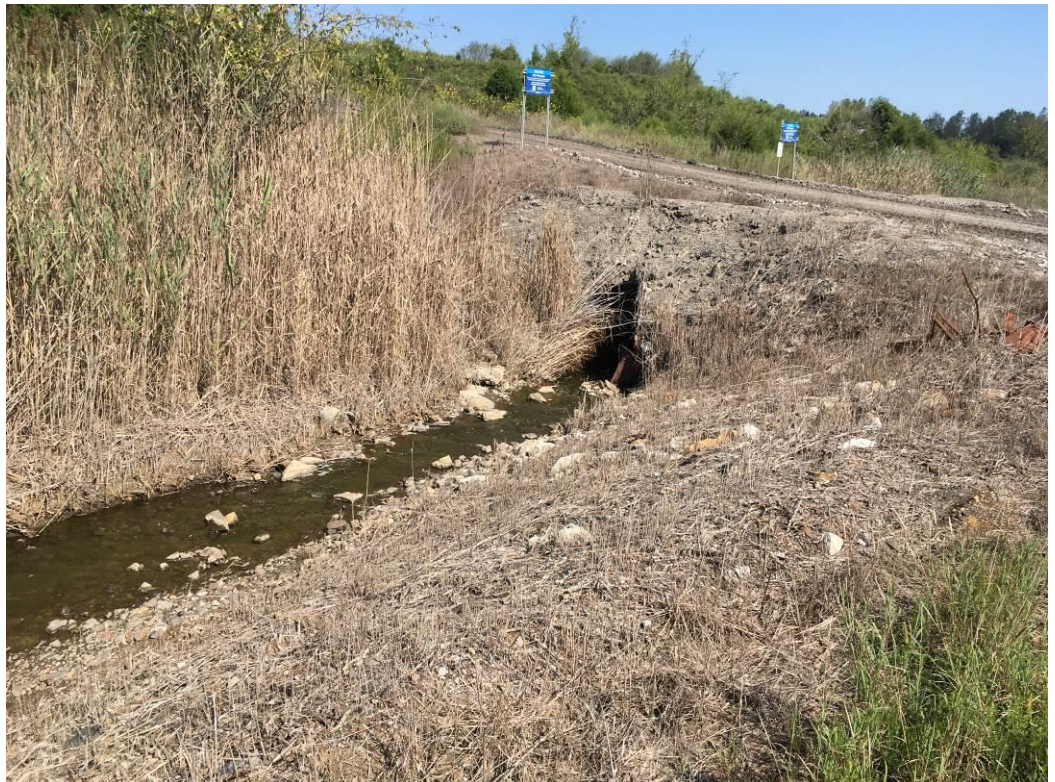
Culvert in leachate stream under haul road, facing northeast.

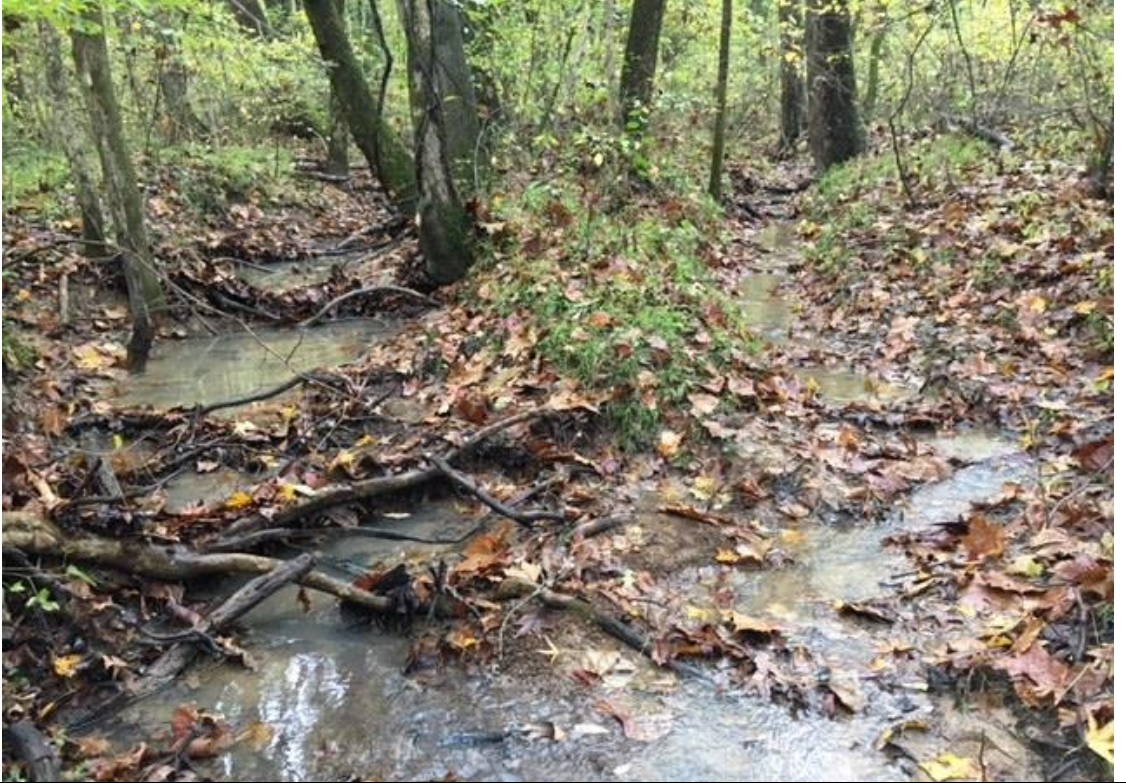
Client Name: Tennessee Valley Authority		Site Location: PAF Peabody Ash Pond Breach Zone	Project No.: 60532201
Photo No.: 3	Date: 10/26/17

Direction Photo Taken: Southwest			
Description: Confluence of Stream 3 and Stream 4

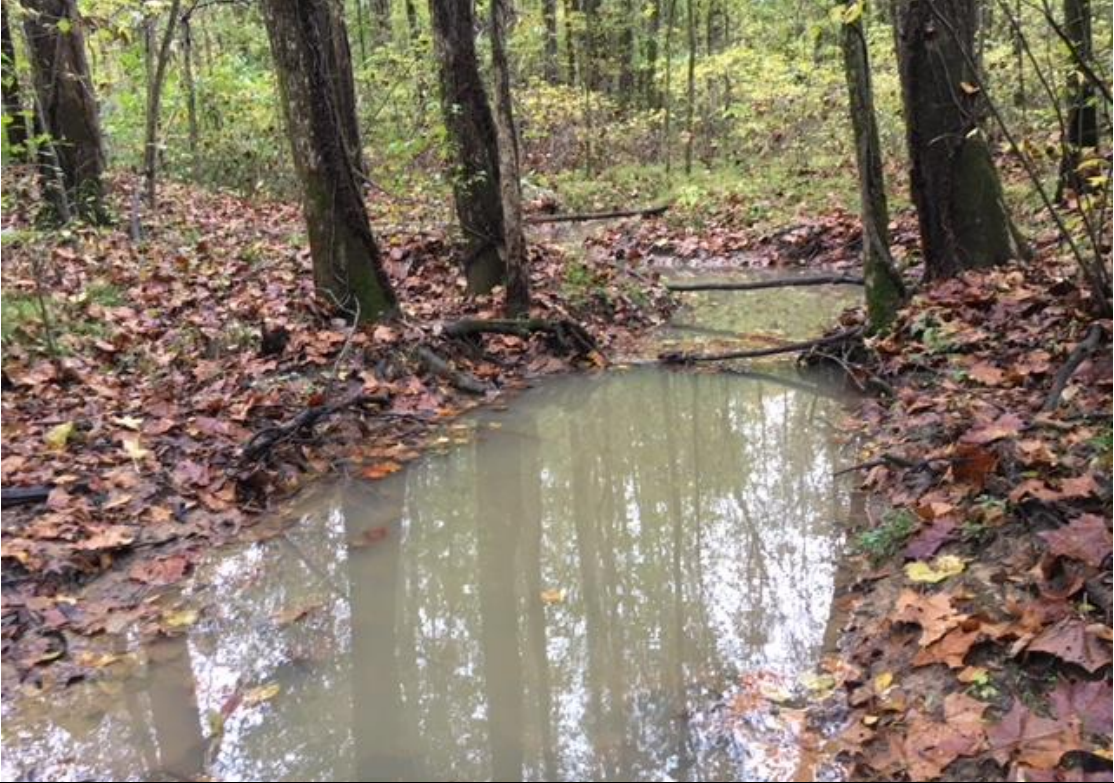
Client Name: Tennessee Valley Authority		Site Location: PAF Peabody Ash Pond Breach Zone	Project No.: 60532201
Photo No.: 5	Date: 10/26/17

Direction Photo Taken: Southeast			
Description: Lower reach of Stream 3 flowing through Wetland 40.

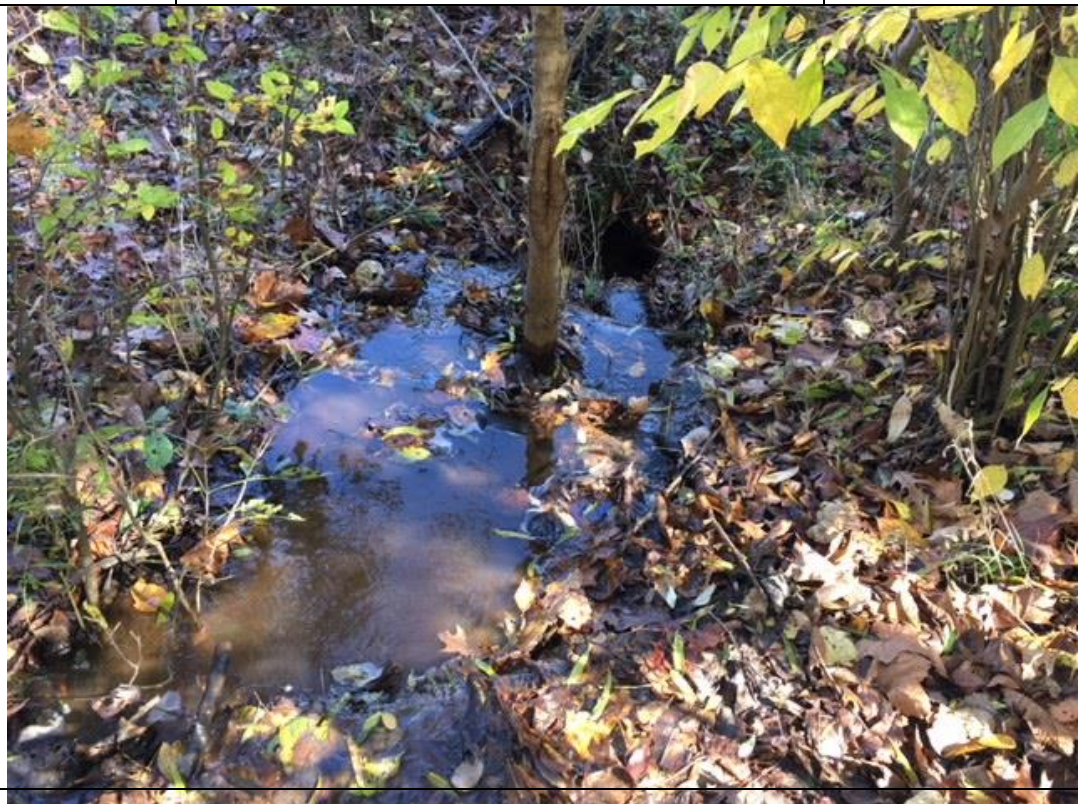
Seep marking the start of Stream 5.

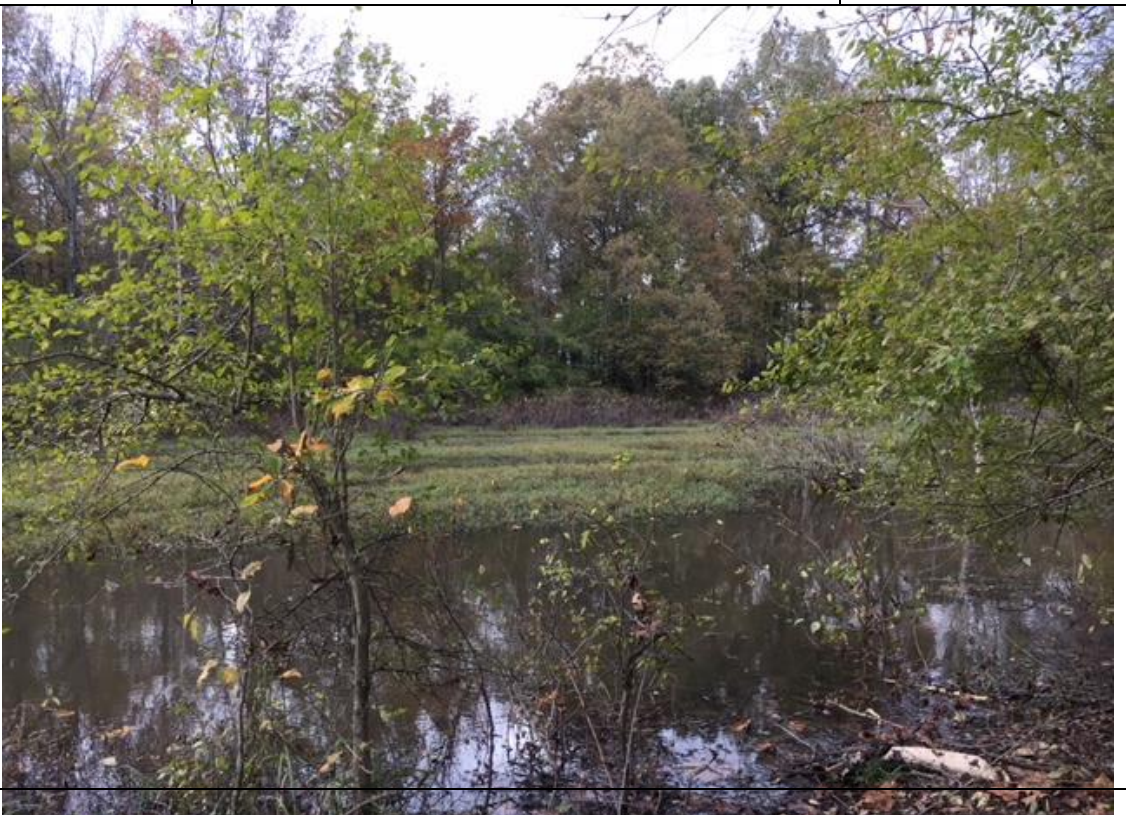
Pond formed by beaver dams in Wetland 36.

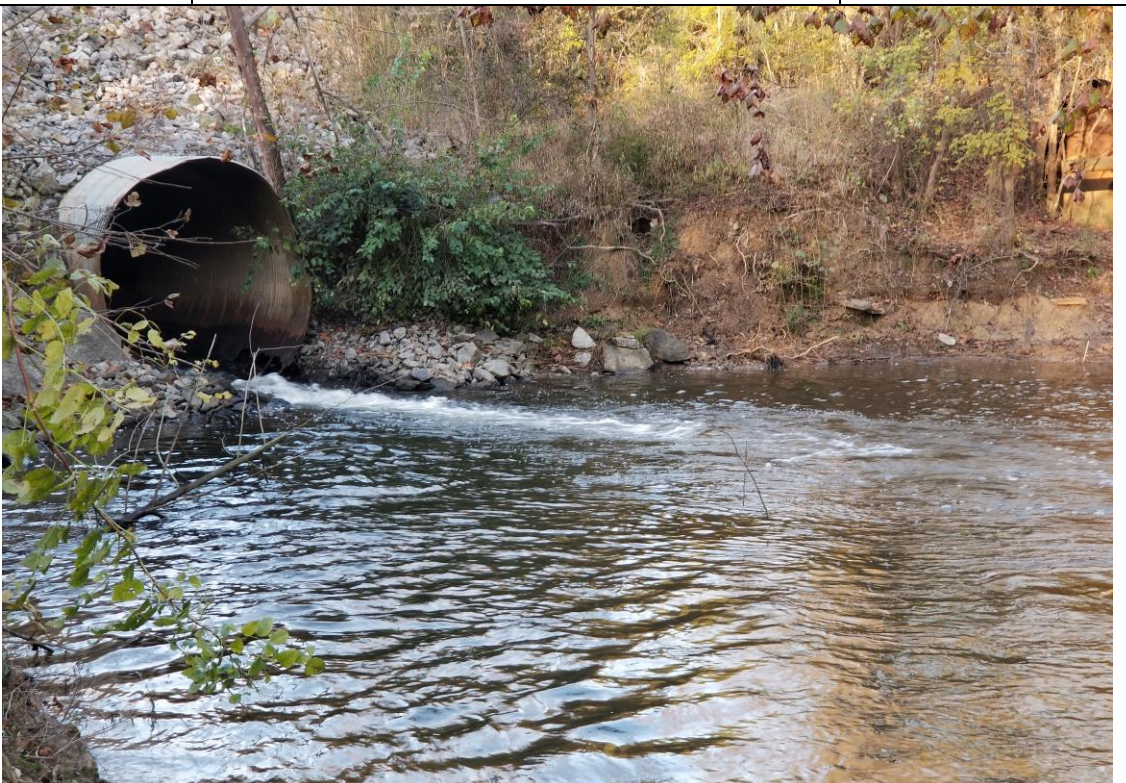
Jacobs Creek flowing through culvert under Riverside Road.

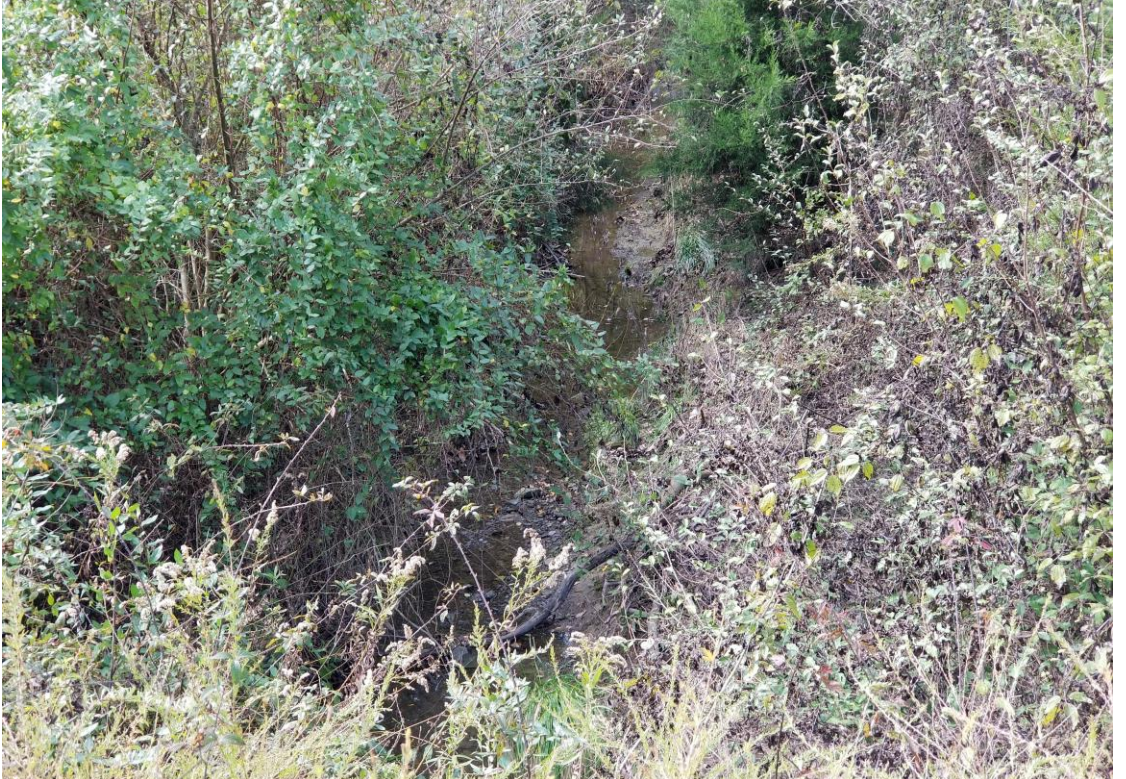
Client Name: Tennessee Valley Authority		Site Location: PAF Peabody Ash Pond Breach Zone	Project No.: 60532201
Photo No. 35	Date: 10/26/17

Direction Photo Taken: Northeast			
Description: Stream 9 looking downstream just below the culvert under dirt road.

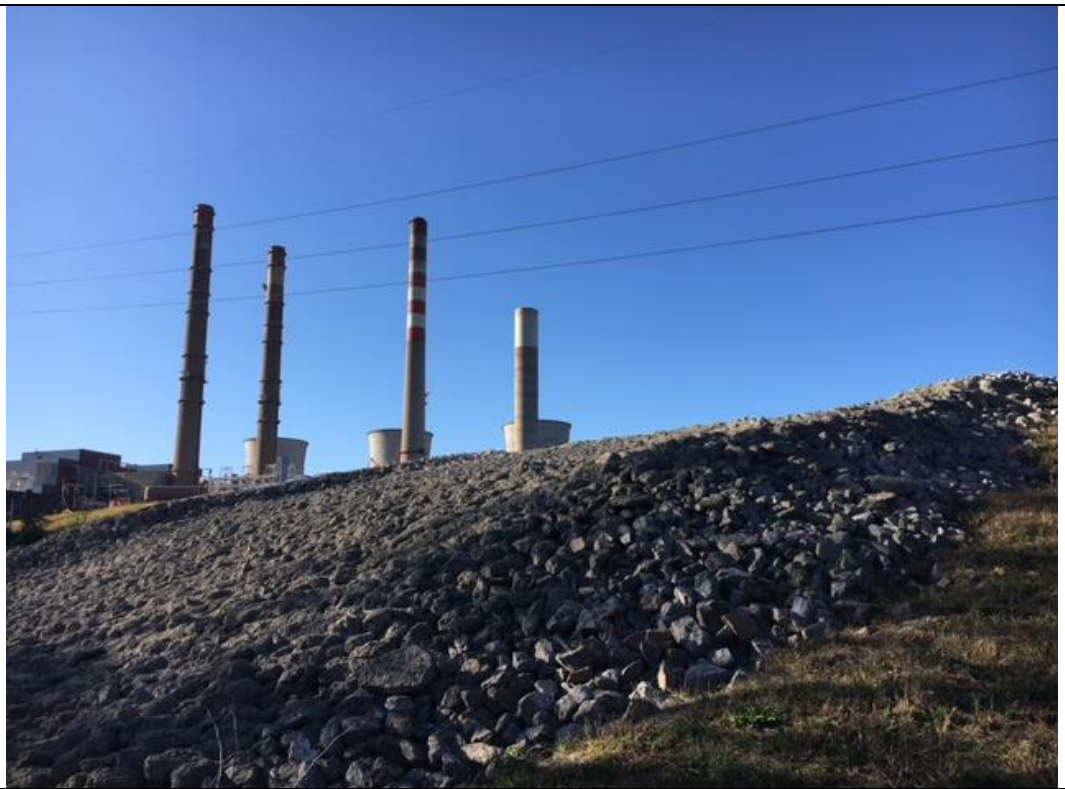
Lower end of spillway

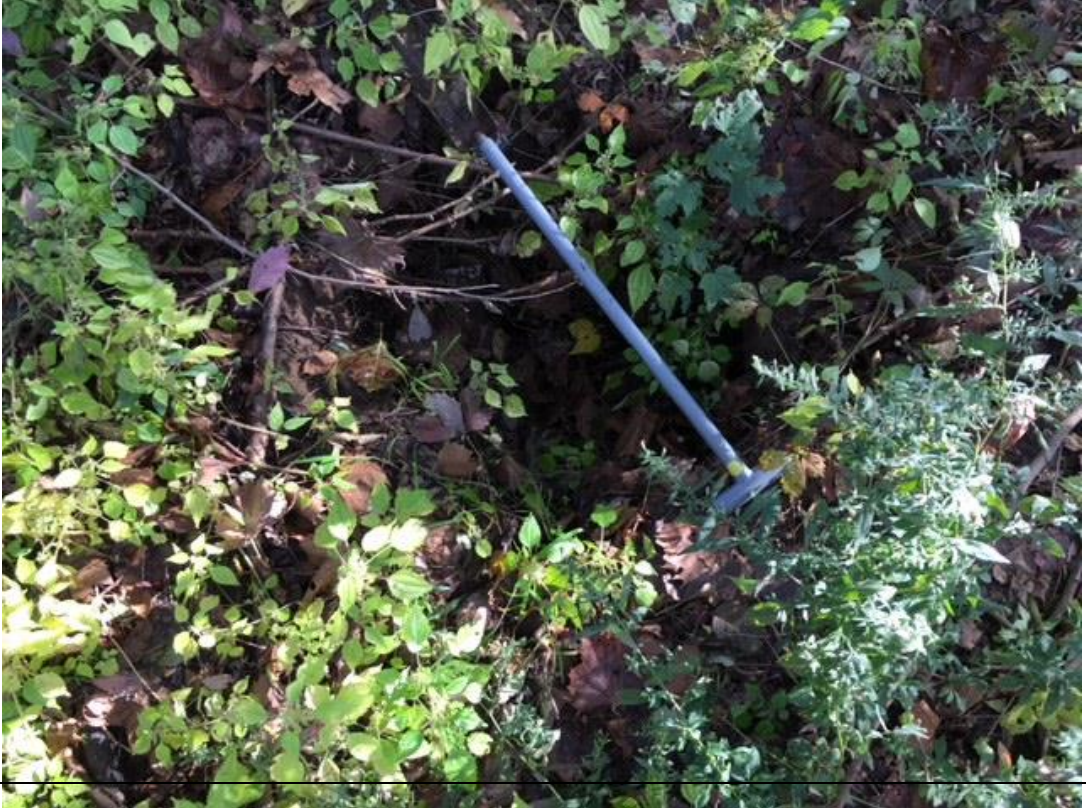
Client Name: Tennessee Valley Authority		Site Location: Paradise Fossil Plant, Drakesboro, Kentucky, Slag Pond Breach Area	Project No. 60532201
Photo No. 3	Date: 10/27/17

Location East of slag pond			
Description: Small sinkhole near Green River Bank
